CITY OF DAYTON
Wastewater System Facilities Plan Dayton, Oregon

Ferry Street Bridge Technical Memorandum
Ferry Street Bridge As-Built Drawings

Re: Life Expectancy and Cost Analysis for
City of Dayton's Ferry Street Pedestrian/Utility Bridge, Yamhill River
OBEC Job No. 299-5

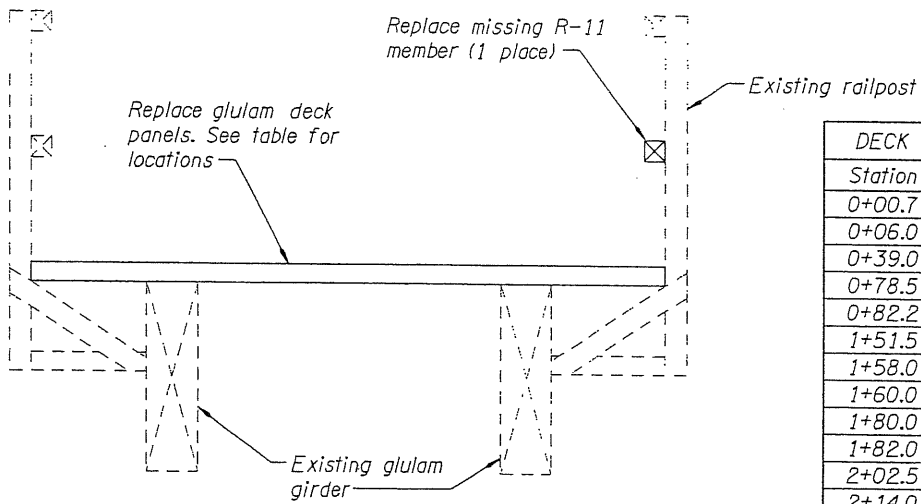
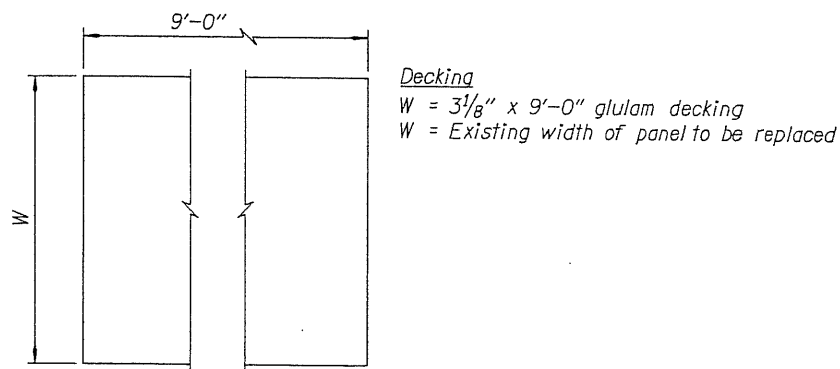
RAIL & DECK REPAIR DETAILS

- *Timber Glulam Decking:* The decking is currently in fair to poor condition with numerous panels showing signs of decay. In June 2008, seven of the most severely decayed deck panels were replaced with new glulam panels. The timber deck sections that bridged the steel rods at Bents 3 and 5 were replaced. These repairs have corrected any immediate danger of local failures and safety concerns. However, I estimate the deck to continue to decay at an accelerated rate and repairs to continue over the next ten years until the deck is completely replaced. Replacement of additional portions of the deck should be scheduled within the next 3 to 5 years. Based on current unit costs of the 2008 contract, the City can expect to spend at least \$200,000 to replace the entirety of the remaining deck.

DECK REPLACEMENT TABLE	
Station	#Decayed Sections*
0+00.7	3
0+06.0	2
0+39.0	4
0+78.5	3
0+82.2	Centerline Bent 2
1+51.5	4
1+58.0	3
1+60.0	Centerline Bent 3
1+80.0	1
1+82.0	3
2+02.5	2
2+14.0	4
2+25.0	2
2+26.0	3
2+38.5	3
2+67.0	2
2+68.0	2
3+18.0	2
3+62.0	3
3+80.2	Centerline Bent 4
4+19.0	3
4+35.0	1
4+58.0	Centerline Bent 5
4+68.0	1
5+14.0	3
5+40.3	Bent 6 face of backwall

*Sections = individual 2 x 4's within panel.
Replace 1'-6" panel in its entirety.
