CITY OF DAYTON
Wastewater System Facilities Plan

Lagoon 4 Preliminary Geotechnical Investigation

Date: October 7, 2008
To: Denny Muchmore, P.E.
Westech Engineering, Inc.
From: James K. Maitland, P.E., G.E.
Subject: Preliminary Geotechnical Investigation
Project: Dayton Polishing Pond Leak
FEI Project 2081077

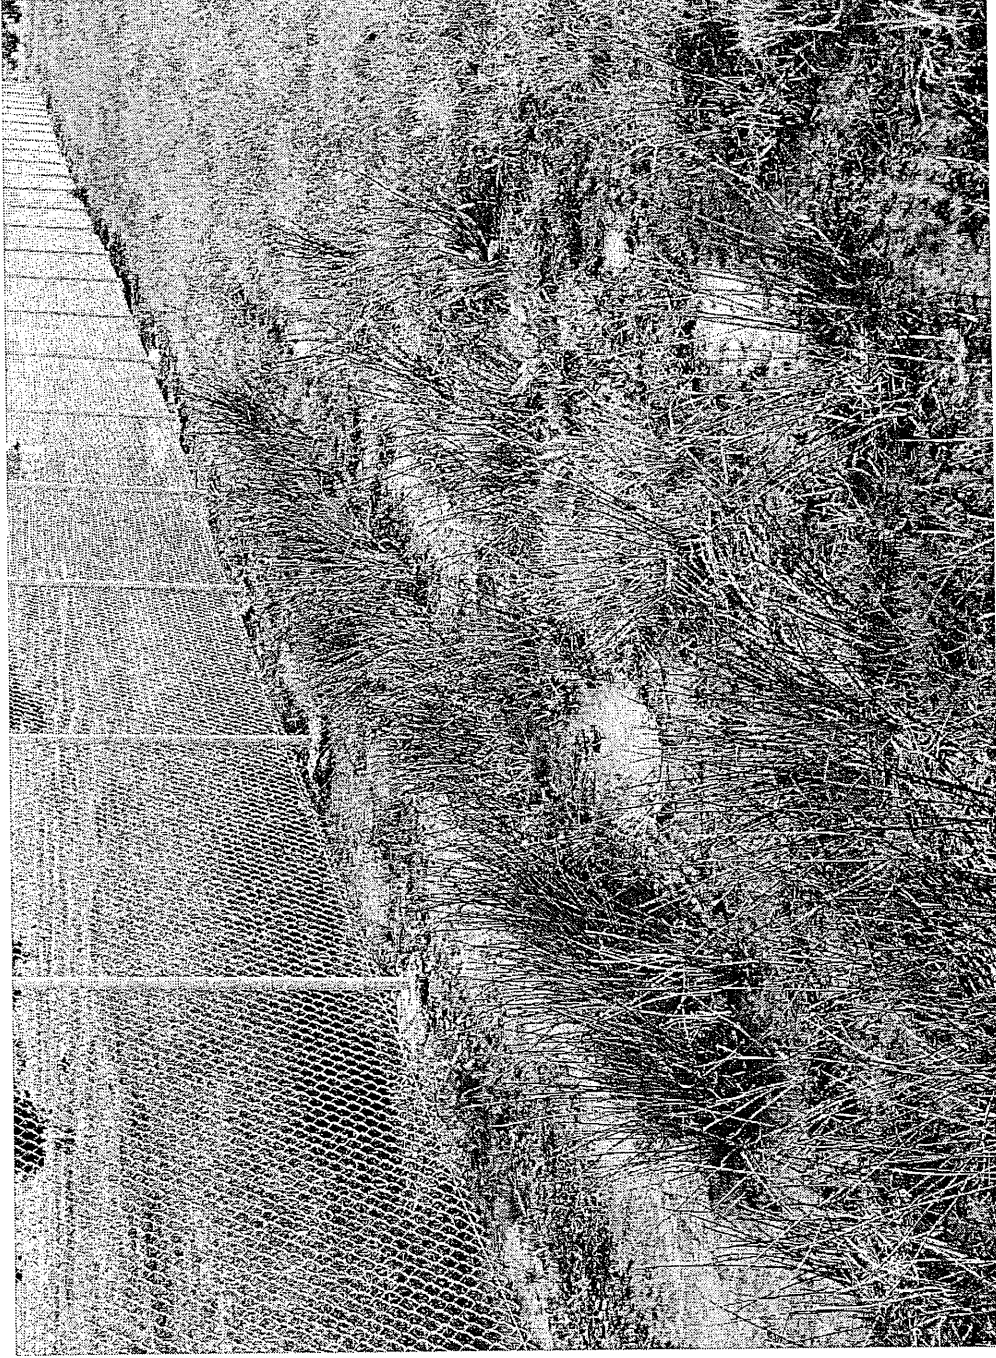
At the time of our site visit, we noted a long, narrow area of ponded water that essentially parallels the fenceline (Photo 1). The ponded water lies ± 50 feet (measured horizontally) from the inside surface of the water. The area of standing water extends over a distance of ± 125 feet. The point of most concentrated moisture is located ± 150 feet from the southeast corner of the pond (Photo 2).

Based on the lack of concentrated seepage on the exterior face of the dike, we have concluded that the observed wet area is not a result of seepage through the upper portion of the dike. Therefore, active internal piping through the dike fill is not likely. Rather, it is likely that the seepage is occurring along the contact between the original dike and the subsequently placed fill. We have seen no records describing the preparation of the surface of the original dike, the lime treatment or the placement of embankment fill. It is possible if the surface of the original dike was dry during construction that a relatively permeable layer formed at the contact between the new and old fill. As the water level rises in Pond 4, it crests over the level of the original dike and, where permeable, water infiltrates, migrating to the east toward the toe of the embankment. Because the wet area is ± 125 feet long, seepage may be occurring along a diffuse (albeit buried) surface rather than at a single, isolated point or series of points. At this time, the seepage appears to be centered at a point ± 150 feet from the southeast corner of the pond.

Photo 1. Moist area along the toe of the embankment.

Because the leakage problem likely represents a diffused infiltration of ground water beneath the top of the dike, repair at a single point is not expected to be effective. Options to reduce or eliminate the leakage typically include grout curtains, sheet pile walls, or other hydraulic barriers to reduce seepage through the core of embankment fill. Since the seepage appears to occur over a relatively long section of the exterior dike, it is likely that reconstruction of the dike is the most viable option. The reconstruction would likely involve exposure of the original dike surface, removal of unsuitable materials (i.e., soft/wet soil), preparation of the exposed surface, and placement of new embankment material. It is likely that the bulk of the existing embankment fill could be reused.

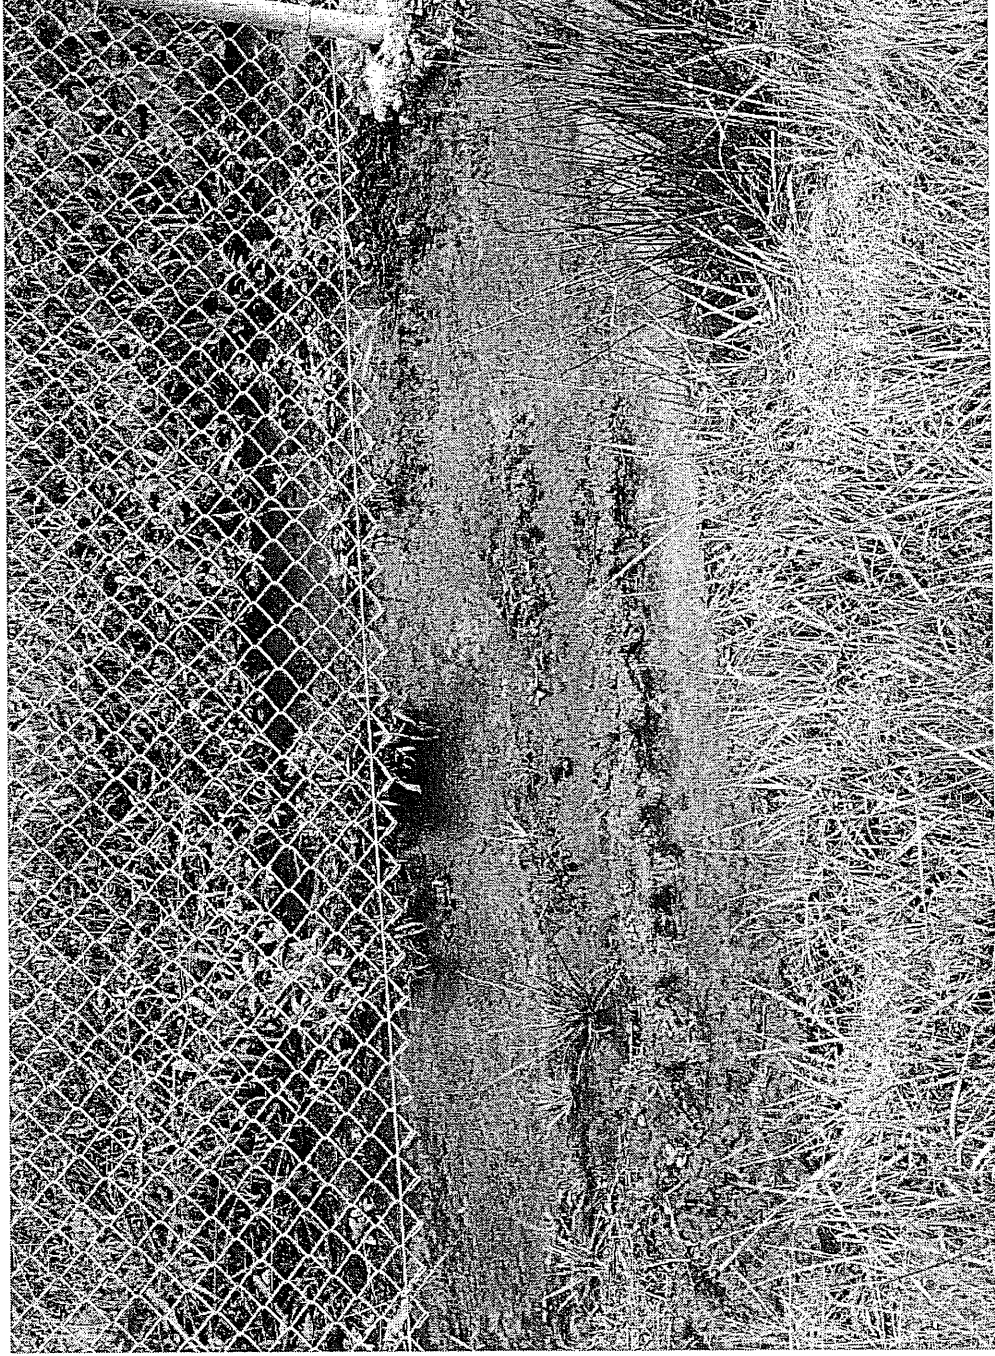
Photo 2. Ponded water at fenceline.

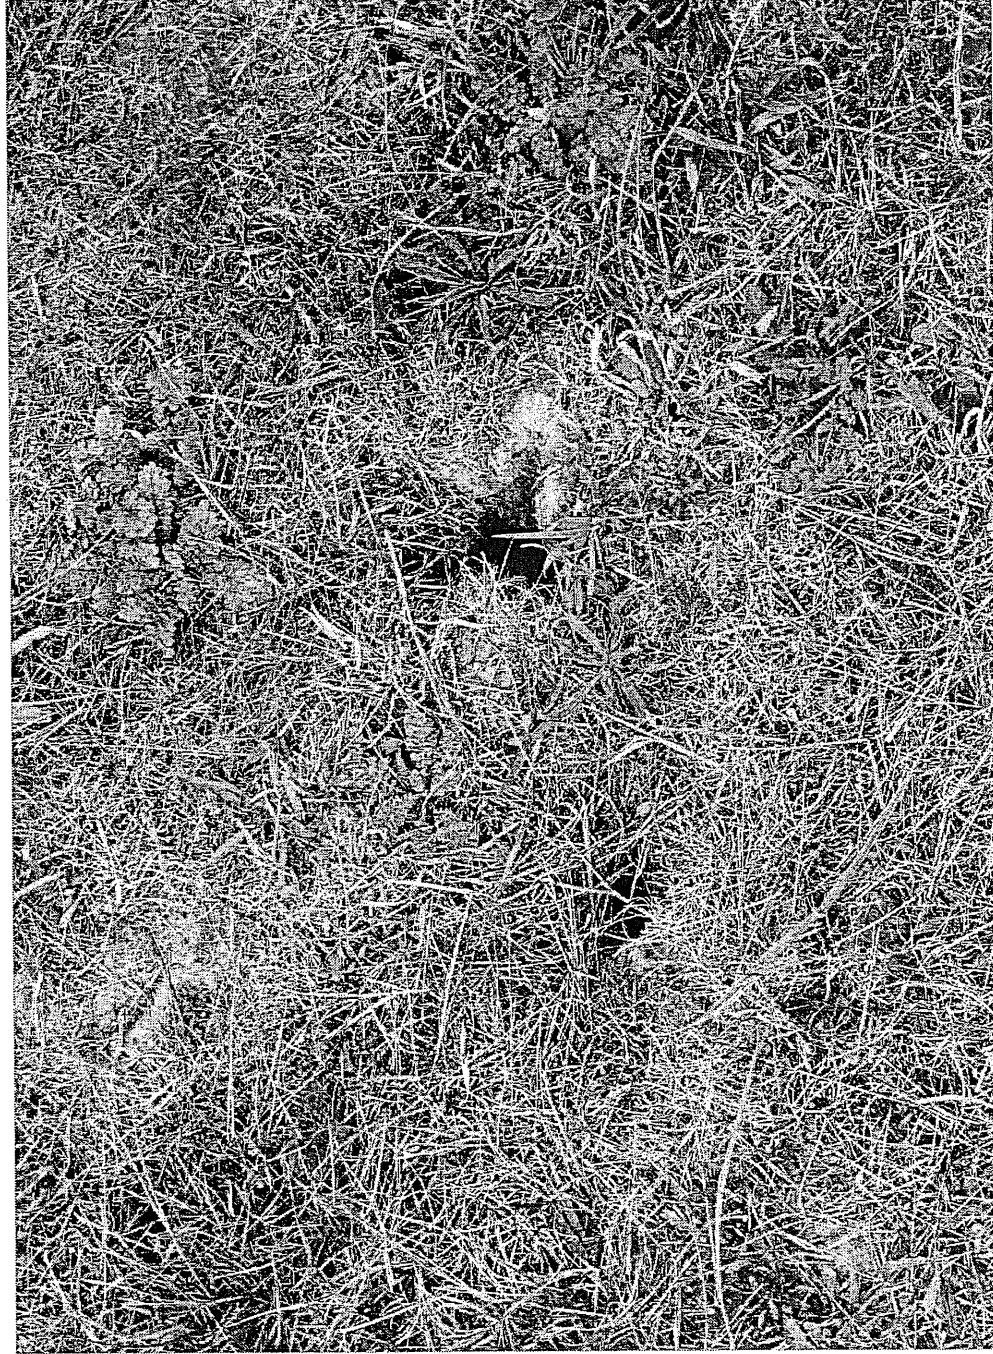
The ground surface exposed on the dike was very dry and we noted some isolated desiccation cracks. The ground surface was also riddled with 1 to 2-inch burrows (reportedly due to voles) (Photo 3). No standing moisture was noted in the burrows and they do not appear to be related to the issue at hand.

Photo 3. Typical animal burrows and desiccation cracks.

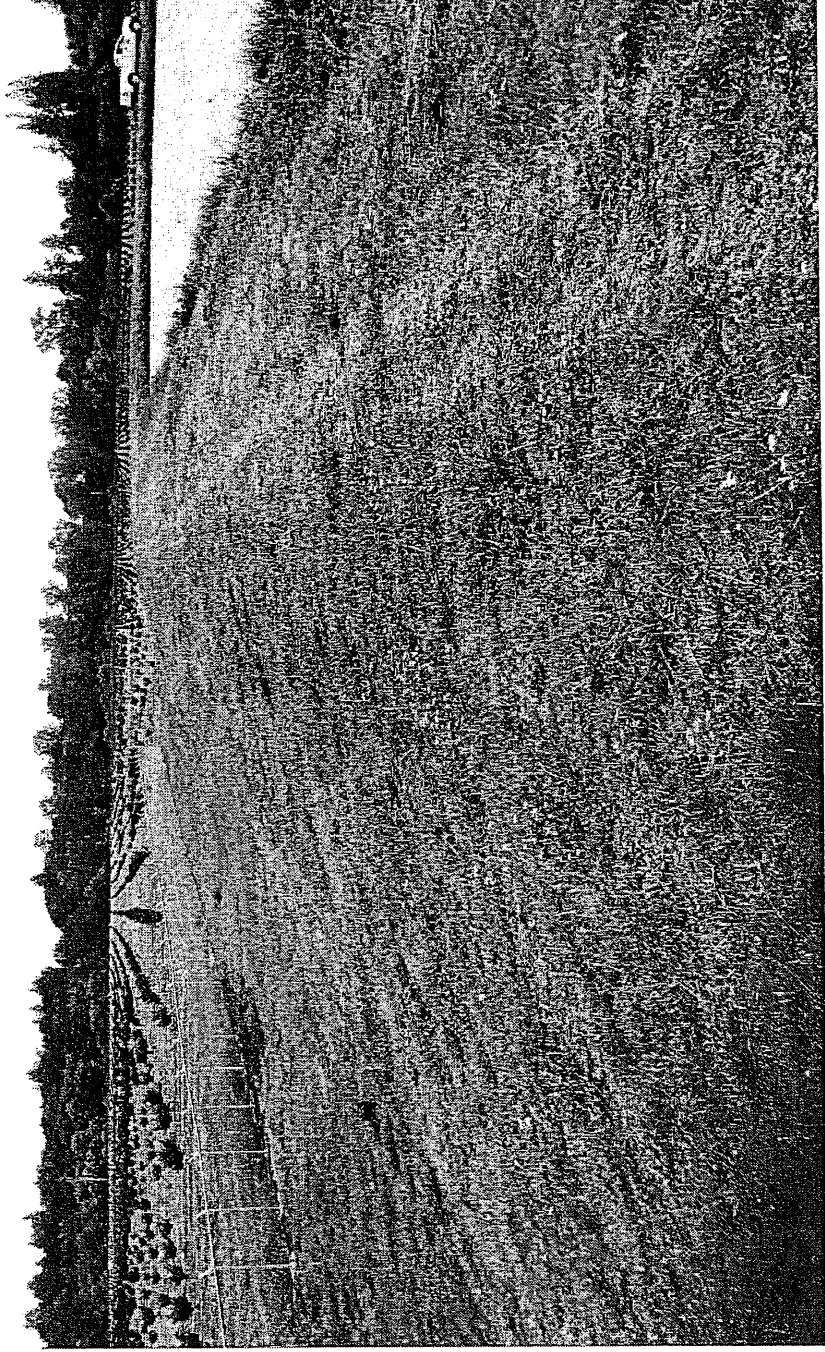
The surface of the dike adjacent to the observed ponded moisture appears to be uniform with no evidence of lateral creep, tension cracks, or scarps (Photo 4). The exterior slope is covered by short grass. The area of ponded water contained significantly greener, taller grasses and scattered pockets of reed grass. Only one small area, near the toe of the exterior slope contained greener grass. Therefore, there is no evidence of concentrated seepage or internal piping emerging from the exterior slope.

The face of the exterior dike slope is uniform and we noted no tension cracks, bulges scarps or other evidence that there is any lateral creep or movement of the slope. The scattered cracks noted along the top and sides of the dike appear to be shallow and consistent with the observed desiccation of the fill. The animal burrows are dry and appear to be too shallow to impact dike performance. Therefore, there is no evidence that the leakage has compromised the structural integrity of the exterior dike nor is there any evidence of on-going slope creep, movement or incipient failure. Therefore, it is our opinion that the risk of sudden, catastrophic slope instability is low.

Photo 4. View of exterior pond slope.
