Engineering Report  
for  
City of Dayton, Oregon

# Seismic Retrofit of Dayton City Hall Annex

*408 Ferry Street, Dayton, Oregon*

*February 23, 2022*

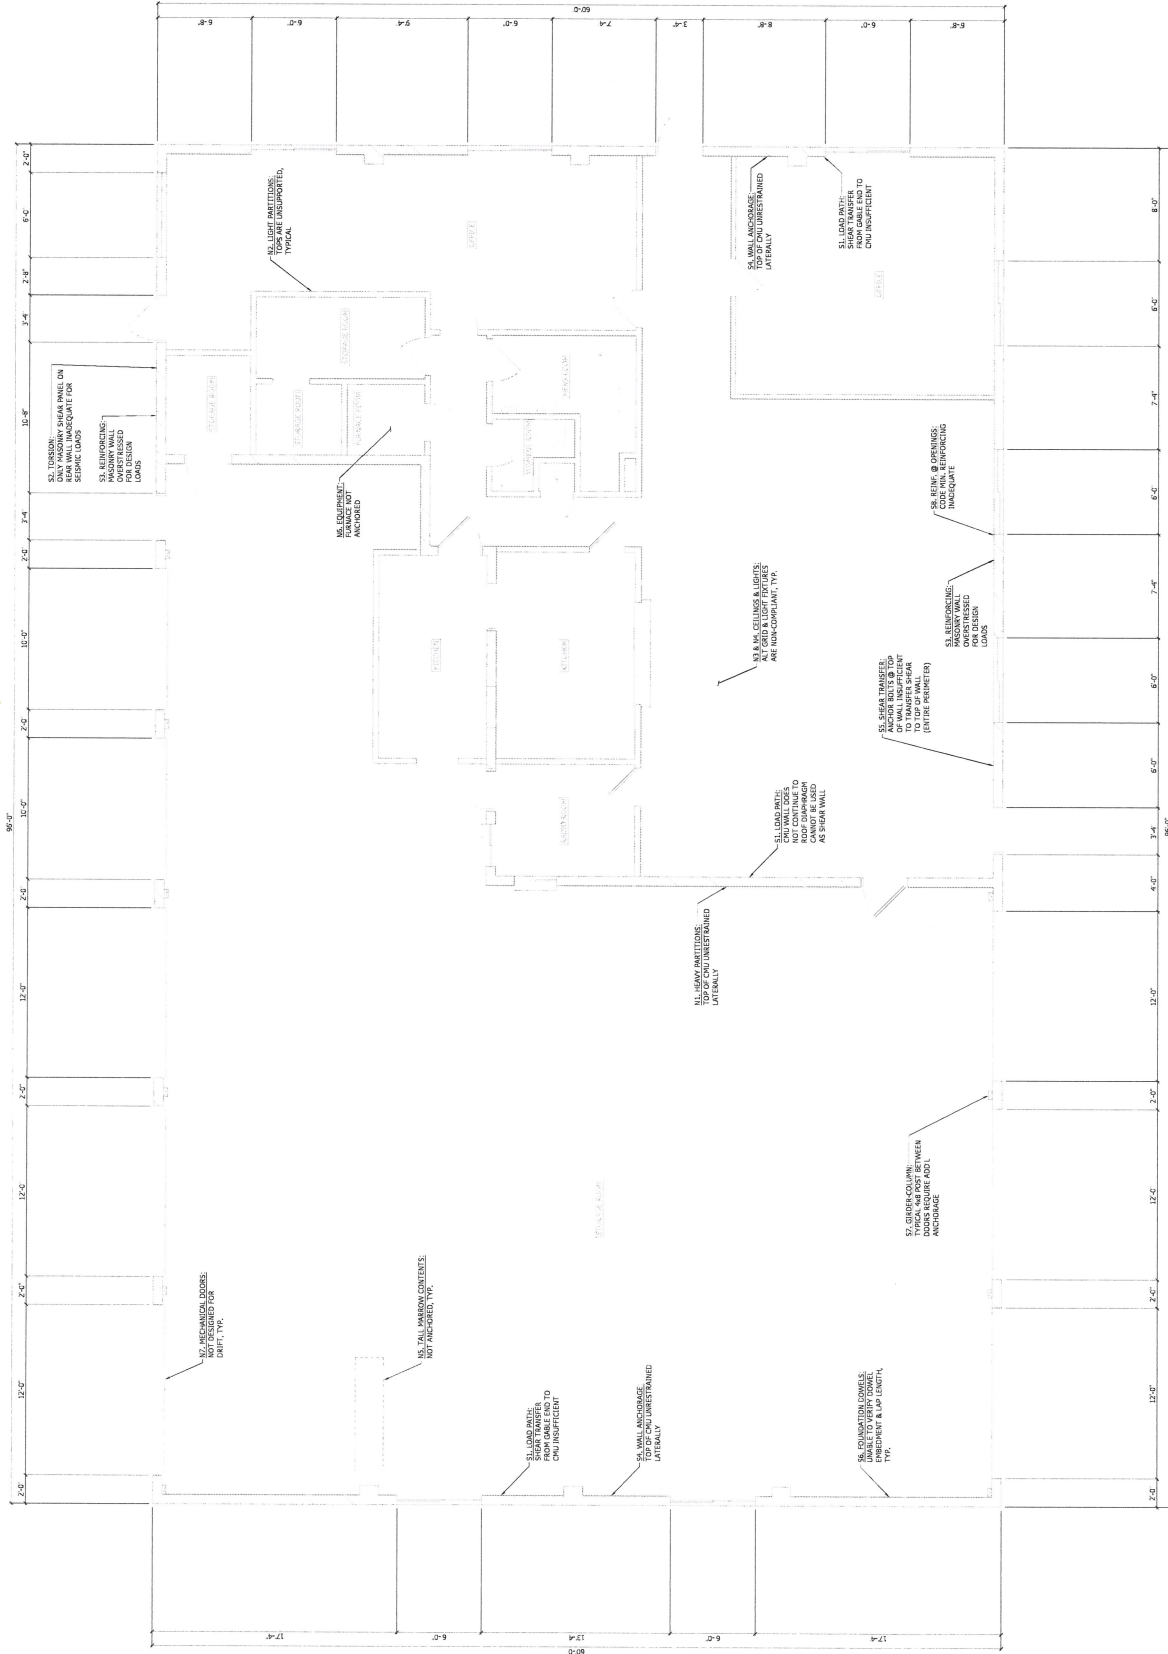
**EXISTING FLOOR PLAN - WITH DEFICIENCIES NOTED**

#	Deficiency	Description
S1	LOAD PATH	The connection between the roof diaphragm and the gable-end shearwalls is not present in the structure. There is insufficient strength in the gable-end truss to transfer the seismic forces to the masonry wall below.
S2	TORSION	Rear (south) wall has more overhead doors and only one full-height wall segment without openings.
S3	REINFORCING STEEL	Reinforcing spacing (@ 48" OC ea. way) was confirmed with use of thermal imaging. Reinforcing sizes were assumed based on 1973 UBC and are non-compliant per ASCE 41-17. Assumed reinforcing was further found to be insufficient for gravity and seismic loads.
S4	WALL ANCHORAGE	The out-of-plane supports for the masonry walls (seismic loads perpendicular to the face of the wall) are not present.
S5	TRANSFER TO SHEARWALLS	The connection of the roof diaphragm to the north and south shearwalls is insufficient to transfer the lateral load to the shear walls.

#	Deficiency	Description
S6	FOUNDATION DOWELS	Length of wall dowels is unknown but is assumed to be insufficient to develop either the wall strength or uplift capacity of foundation.
S7	GIRDER-COLUMN CONNECTION	The connection of the 4x8 post to the glulam beam at the overhead doors is questionable. ASCE 31-03 prescribes that steel connectors be used. The installed connector is plywood gussets.
S8	REINFORCING AT WALL OPENINGS	The assumed masonry wall reinforcement based on the 1973 Uniform Building Code reference is under-reinforced for the combined lateral and gravity loads at the windows jambs.
S9	CROSS-TIES	Wood trusses may act as cross ties in one direction but no cross ties or sub-diaphragm elements are present perpendicular to the trusses.
S10	UNBLOCKED DIAPHRAGM	The roof diaphragm construction is 3/8" CDX plywood over flat 2x4's @ 24" OC. There is no blocking between the 2x4's and the current spans exceed maximum allowable per ASCE 7-41.

#	Deficiency	Description
N1	HEAVY PARTITIONS SUPPORTED BY CEILINGS / DRIFT	Interior masonry walls are not connected to the roof structure or detailed to accommodate drift.
N2	LIGHT PARTITIONS SUPPORTED BY CEILING / TOPS OF PARTITIONS	Interior partition walls are not supported above ceiling.
N3	INTEGRATED CEILINGS / EDGE CLEARANCE / EDGE SUPPORT	Lay-in acoustical tile ceiling is non-compliant. No diagonal tie wires were observed and edge supports are non-compliant.

N4	LIGHT FIXTURES / LIGHT COVERS	Existing light fixtures are non-compliant
N5	TALL NARROW CONTENTS / FALL PRONE CONTENTS	Bookcases, shelves and similar items are not anchored.
N6	INLINE EQUIPMENT / TALL NARROW EQUIPMENT	Electric furnace is not braced.
N7	MECHANICAL DOORS	Overhead doors at apparatus bays are not detailed to operate at specified drift limit
N8	FLEXIBLE COUPLINGS	Water lines are run under the slab but do not have flexible couplings to fixtures.
