Brookside Cemetery 2018-2027 Preservation Plan

Written by: David Pinyerd and Bernadette Niederer
Historic Preservation Northwest
1116 11th Ave SW
Albany OR 97321
541-791-9199
www.hp-nw.com

Written for: City of Dayton
Dayton School District
Brookside Cemetery Association

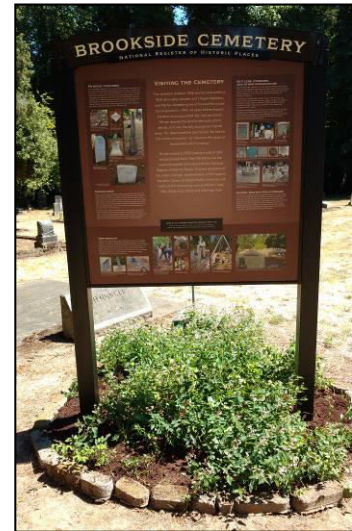
The only signage in the cemetery is a new interpretive sign at the end of Third Street, the gateway to the cemetery. The permanent sign is steel and replaces a plywood sign as part of this CLG-funded project. The new sign provides the history of the cemetery, general information about the cemetery rules, and includes several photos of the restoration work done as part of this project.

The new interpretive sign for the cemetery installed July 2018.

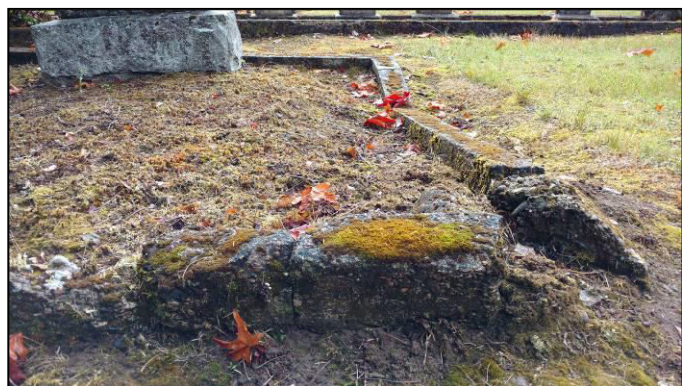
Example curbing deterioration in the cemetery.

The condition of the curbing ranges from good to severely deteriorated, with damage in the form of cracking, broken sections, delamination, spalling, uneven settling, lawn mower damage, and/or displacement from shrubs and or tree roots. Some of the curbs have been undermined

by burrowing animal activity. Lawnmowers have damaged some curbs at the corners. Although the curbs pose maintenance issues, these enclosures do protect the headstones.

Treatment: Reset dislodged curbing if sections are structurally stable. Repair or replace damaged sections of curbing. Retain as much of the historic material as possible, especially when the curbing is made of stone. Replace severely deteriorated sections of the enclosures matching the material, dimensions, texture, design, and color of the original enclosure. Consult with a qualified mason prior to the repair of the more elaborate curbing. Most repair work can be accomplished by volunteers under the supervision of a qualified contractor while other more difficult repairs should be accomplished by a trained professional. There is a lot of curbing that needs repair; fortunately, most of the curbing is concrete with no decorative elements and is a low priority.

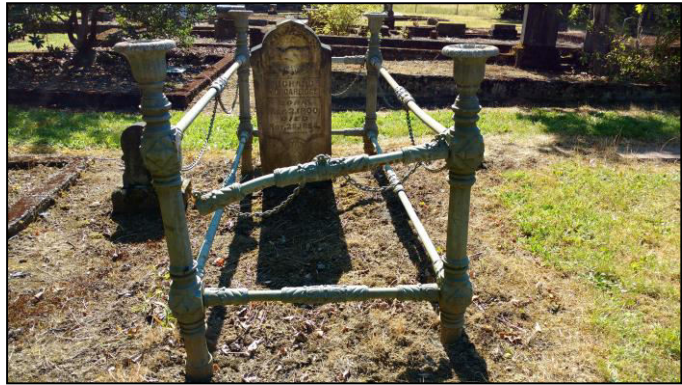
Fencing: Cast and wrought metal fences and other simple enclosures surrounding lots or family blocks were common in nineteenth and early twentieth century cemeteries. They are considered valuable resources due to their scarcity, which was caused by deterioration, removal during the scrap metal drives of the World Wars, and later, for maintenance reasons. In Brookside Cemetery, there is only one fenced enclosure (Marker #14.13). Referred to as a “gas pipe fence,” it is in good condition with a sheared-off connection at the southeast corner being its only damage.

Richard Morgariedge's headstone (Marker #14.13) from 1884 is the only fenced burial in the cemetery.

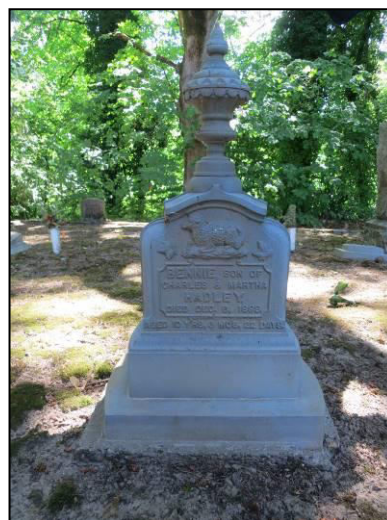
Zinc marker #03.18 for Bennie Hadley.

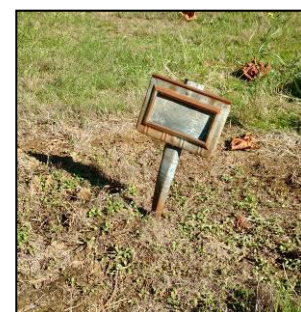
A last type of grave marker found is the temporary metal stake, generally used to mark a grave before placing the permanent headstone. There are many metal stake markers throughout the cemetery, some next to headstones, others possibly delineating a grave; however, none of the metal stake markers in the cemetery have any remaining identifying information.

Temporary metal stake grave marker.

Several of the temporary metal stake markers have never been replaced with more permanent stone or metal markers. The metal stake markers once had a paper name plate, but all names have since disintegrated, leaving no on-site record of the burial. These stakes have also been removed for landscape maintenance, damaged by equipment, or vandalized.

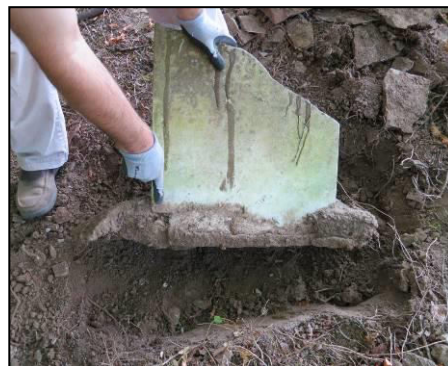
Previous Repairs: Over the decades, Brookside Cemetery has undergone cycles of restoration and repair. Although well intended, some of these efforts have contributed to the deterioration of markers. Some were repaired or reset using mortar with a high percentage of Portland cement in an effort to make a lasting and strong bond. This practice often leads to the further deterioration of the stone. Generally, the mortar should be weaker than the original stone so that moisture penetration and resulting expansion/contraction cycles will be more likely to break the mortar rather than the stone. Improper repairs have accelerated deterioration of these grave markers.

Several markers had breaks repaired with an early epoxy. Unfortunately, this epoxy tended to run out of the break line, down the stone, and then discolor over time. There is no method of removing old epoxy without damaging the stone.

Several markers have had their bases altered with concrete. One method seen was to remove the base and then place the headstone vertically into a concrete pad. Concrete often fails before the stone as there is a water infiltration gap ready-made at the point stone meets concrete. Another method used was to pour a ring of concrete around the base of the monument under the impression the stone will never move again. Unfortunately, the stone and the concrete will begin to move as one unit making future leveling difficult.

J N Flint's headstone (Marker 16.23) had been epoxied previously. The epoxy dripped out of the repaired break and then discolored over time. In addition, the stone had been reset in concrete without its original base.

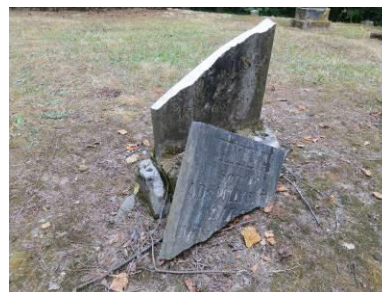
Marker 04.16 had a very fresh break which is an ideal time to repair as it has not yet had time to weather. In this state, the repair can be made practically invisible.

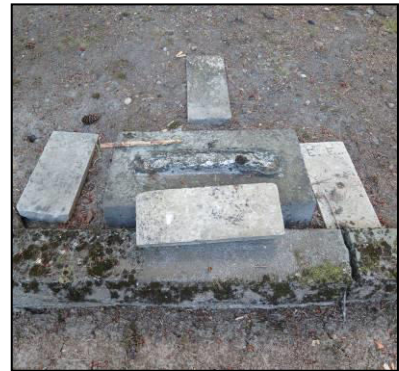
Dislocated Stones: There are stacks of footstones in several spots in the cemetery. Often these dislocated stones are piled around bases missing headstones. Most of the footstones are unmarked but some are marked with initials. Some footstones that belong with headstones are merely leaning against the headstone. It is thought that this dislocation occurs when a footstone is in the way of landscape maintenance. While releveling a headstone as part of this project, a footstone was found buried alongside the headstone (Marker #20.01).

Marker 02.04 is missing its headstone but the base has four random footstones in its place.

There are at least 28 dislocated footstones in the cemetery. Retain all dislocated grave markers and marker fragments that have been removed from their original location. Their original location may be discovered in the future or small fragments might be used in the restoration of other markers. About half of the dislocated footstones have initials on them that will aid in their relocation.

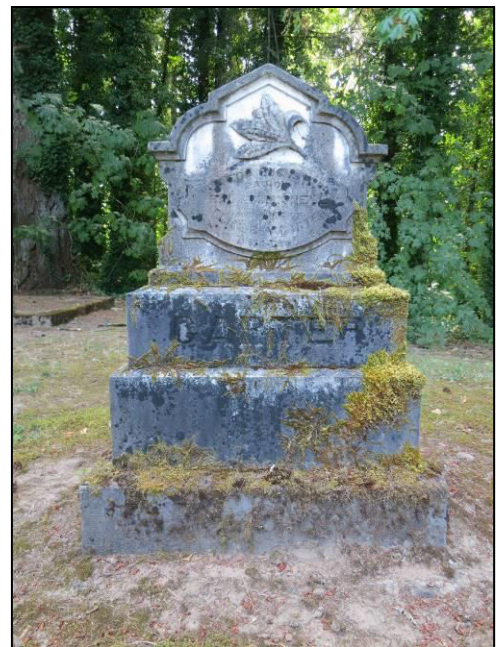
The Meda Degusta Snell Carter headstone covered in moss (#03.32).

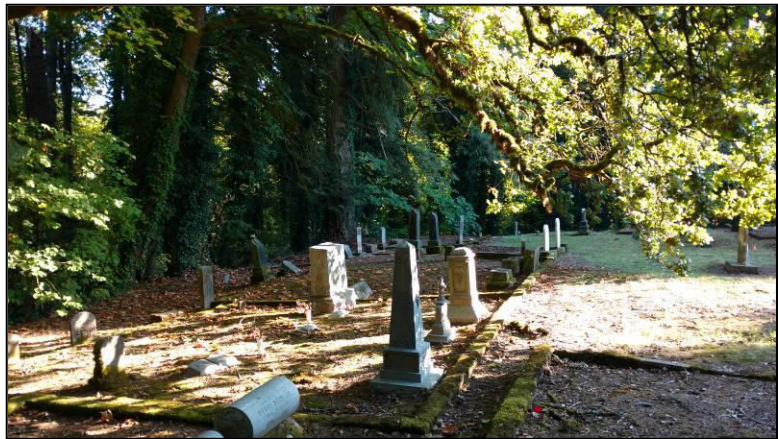
Tree limbs extend from the surrounding forest several rows into the cemetery.

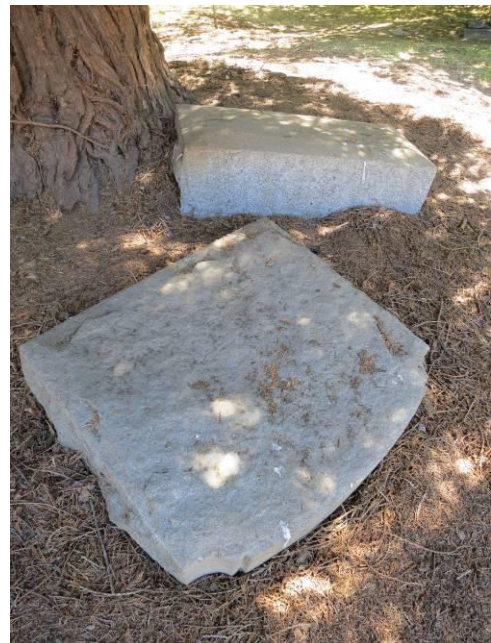
Headstone #07.09 lifted and toppled by Western red cedar.

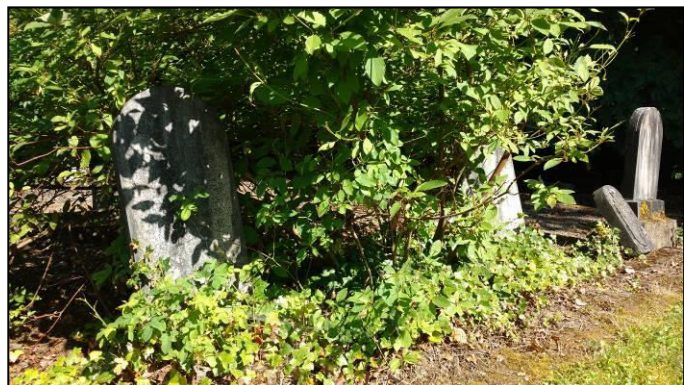
Ivy and black huckleberry envelope stones #13.12 and #13.13.

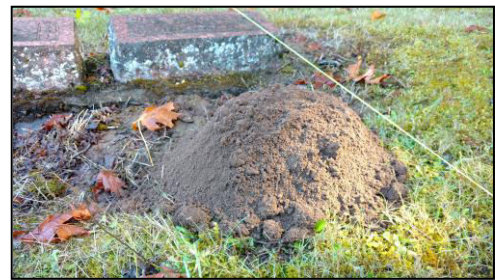
Signs of fresh burrowing in the cemetery.

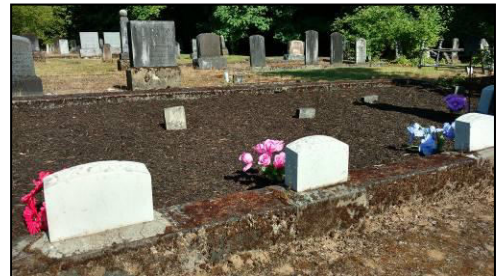
A family plot with curbing and filled with bark mulch by the descendants.

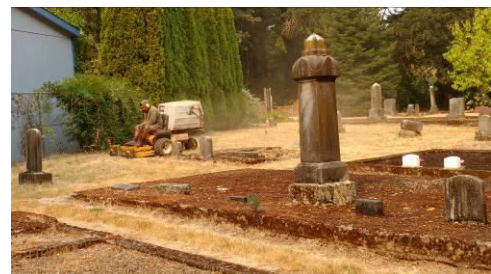
Some of the damage to the grave markers and curbs is caused by maintenance equipment. A number of grave markers have been chipped and scraped by accidental strikes from equipment. This kind of damage is especially evident around the bottom of the soft marble tablet markers and other types of markers made of softer stones, such as sandstone. Headstones that have fallen off their bases and leaned against their bases are particularly vulnerable. Footstones have been scattered about the cemetery and may have been removed over the years to make lawn maintenance easier. The stones most protected from landscape maintenance are those within the safe confines of family plot curbing.

Lawnmower tearing through the cemetery at an almost incomprehensible speed.

A riding lawn mower is used in the areas where it can fit. This equipment is surprisingly maneuverable but can easily cause damage to cemetery objects if not used properly. We saw it in operation on one occasion as it tore through the cemetery with incredible speed and agility. That said, the operator appeared to not strike anything but grass. However, one wrong move would have likely damaged a stone or a curb. The Oregon Commission on Historic Cemeteries has issued a [position paper](#) on mowing in cemeteries.

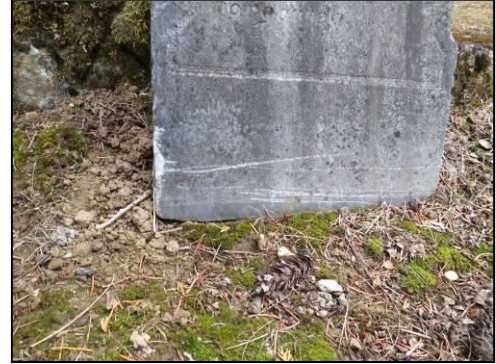
The George L. Alderman headstone is off its base and has subsequently been struck repeatedly by string trimmers (#05.11).

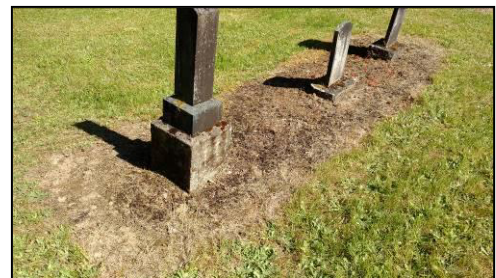
Herbicides have been used to reduce maintenance particularly around the base of gravestones. Herbicides can cause deterioration of the softer stones such as marble. The trade-off is that string trimmers can also damage stone. The best solution is a very carefully wielded string trimmer with a string guard or applying the herbicide while a spray shield is held against the stone bases.

Herbicides can damage softer stones.

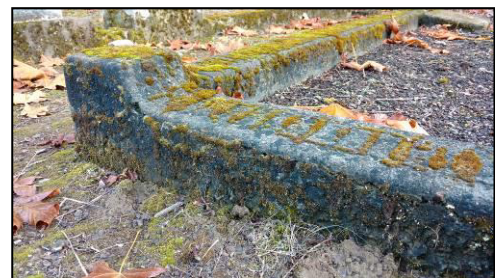
One of the most elaborate curbings at Brookside. Most are simple, concrete affairs with no elaboration or detail.

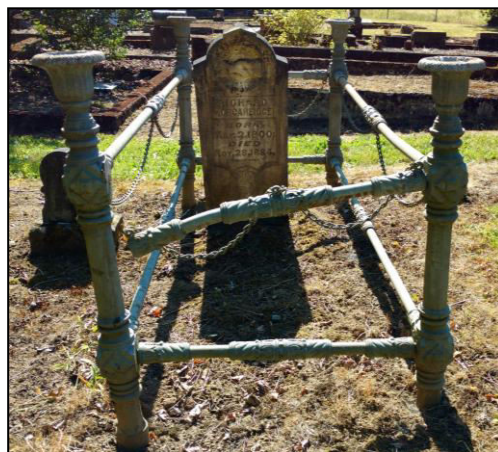
There is only one fence in the cemetery: the pipe enclosure for Richard Morgariedge's plot (Marker #14.13). Referred to as a "gas pipe fence," it is in good condition with a sheared-off connection at the south-east corner being its only damage. The fence is basically made of standard galvanized pipe with fancy cast connectors. Unfortunately, the sheared-off cast connection is not easy to repair. The bent pipe will have to be either replaced with a new galvanized pipe or straightened. A metal epoxy would likely serve to repair the cast connector. Someone experienced in working with metal should be able to make the repair, as long as the repair is invisible. The temptation to paint the galvanized metal should be resisted. The fence has done very well unpainted for over 100 years. Do not introduce a coating that will need to be maintained.

The fence for Richard Morgariedge's plot (Marker #14.13) from 1884 needs a small repair.

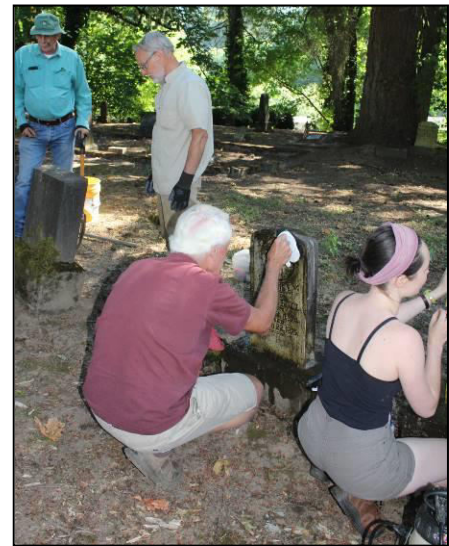
Trained volunteers cleaning at Brookside, July 2018. (Courtesy of Kim Courtin)

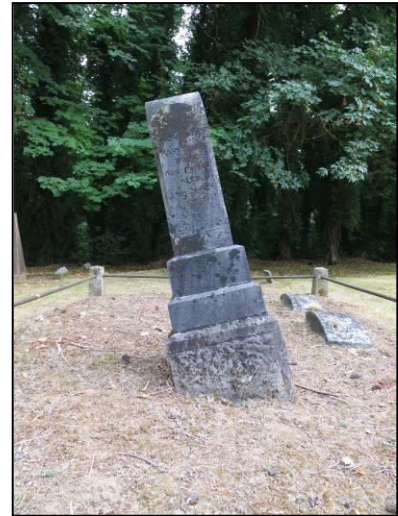
Marker 09.23 was leaning at 12 degrees. It was releveled as part of this project in September 2017.

Very careful prying with a long bar comes next. Some markers are too heavy to lever and will require a tripod to lift. A professional should be doing the work if a tripod is necessary. Once the marker is held at level, then push in and pack gravel (3/4” minus works well) under the monument to support and distribute its weight. Check vertical with an inclinometer frequently. Using gravel works very well as it is an inexpensive and completely reversible leveling method. In cemetery work, nothing lasts forever, but the next relevel will be much easier if gravel is used rather than concrete.

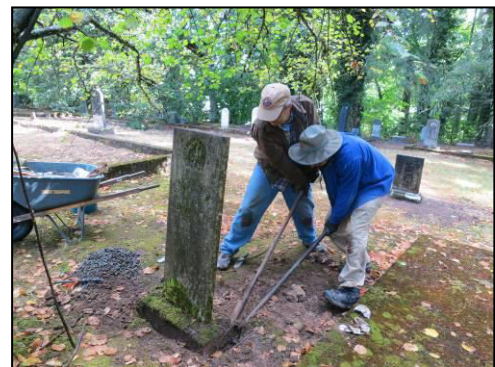
Often leveling takes no more than a stout pry bar and some gravel. Other times the weight is too great and a tripod is needed. Stone is heavy – figure 200 pounds per cubic foot to be on the safe side.

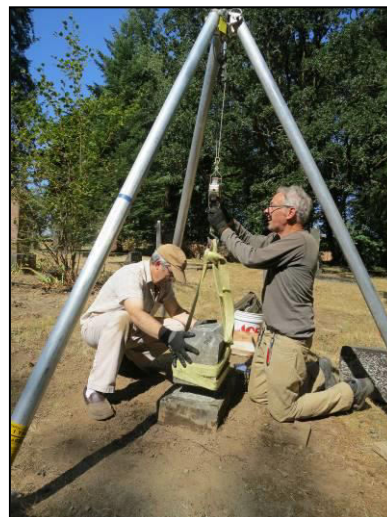
Resetting the plinth for Marker 08.19 on a bed of fresh mortar.

Mortar: Reset stones using lime mortar where there was lime mortar originally – it is as simple as that. If it is a break in a stone, then turn to epoxy, but when resetting a stone where there was originally mortar, it is best to repeat the setting with mortar. However, if it is obvious the originally mortar failed because the stone surfaces were too smooth, such as on granite, or the existing mortar is still well attached to the bottom of the stone and dry fits well, then epoxy might be the best choice. This is why a professional should do the resetting: each stone is decided on a case-by-case basis.

Do not use concrete, do not use any off-the-shelf mortars, all are too hard. You need the softness of lime mortar to prevent damage to the stone. The mortar joint has to be the weak link on a monument.

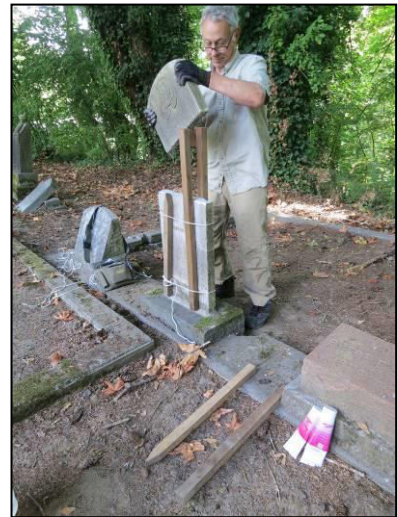
Tablet Marker 01.19 in four pieces being epoxied by Bruce Howard.

Priorities: Repair of severely damaged or broken markers is a specialized task. Each stone type and material must be evaluated prior to proceeding with any repairs. Incompatible adhesives or epoxies, such as the use of Portland cement, concrete, or some types of adhesives, may cause further damage. Markers have to be carefully matched horizontally as well as vertically to ensure proper bonding of the parts.

Epoxy: Use epoxy as a last resort since it is a permanent alteration to the stone. Use it sparingly and very carefully. Use epoxy on tablet breaks where there is not enough surface area and thickness for mortar to make a long-lasting, sturdy bond. The stone epoxies have evolved to a point where they are effective and versatile.

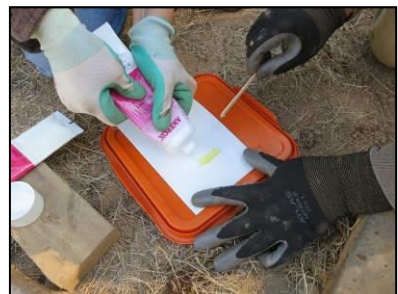
Akepox 2010 epoxy being squeezed out at a 2:1 ratio.

Akepox by [AKEMI](#) has become the preferred epoxy for cemetery stone work. AKEMI is a German adhesive company established in 1933. Their products can be obtained relatively easily from a variety of vendors on the internet. [Akepox 2010](#) is the current standard for repairing a break in a stone. It is a two-part epoxy mixed at a 2:1 ratio. The epoxy comes in tubes which is ideal when making repairs in the field.

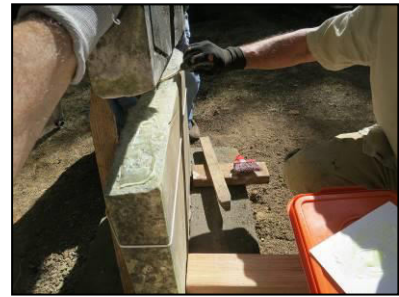
Carefully applying epoxy, keeping it well back from the edges and only where the two stones will touch.

It is best to make repairs in position so that the stone does not have to be moved after the repair. Curing vertically will make for a stronger joint, too. First, make sure the pieces are clean and dry. Use a very soft wire brush on the faces of the joint to

really clean the surface to be epoxied and to slightly abrade it. This is the only time you will use a wire brush in a cemetery.

Second, dry fit the two pieces of stone to be epoxied. Mark with a pencil where the two pieces do not touch. Third, lift off the stone and apply the epoxy, thinly and sparingly to the areas on the lower stone where the two stones will touch. You do not have to have epoxy every place the stones touch and you definitely do not want epoxy squeezing out from the joint when weight is applied. Any epoxy that does squeeze out of the joint, immediately and carefully scrape it off and do not smear it on the stone. Epoxy is a one shot deal and is best left to the experienced professionals. Immediately brace the stone and leave it undisturbed. Epoxy will set quickly so that the stone repair can be touched within 30 minutes; however, leave your bracing on the stone overnight and remove the braces the next day.

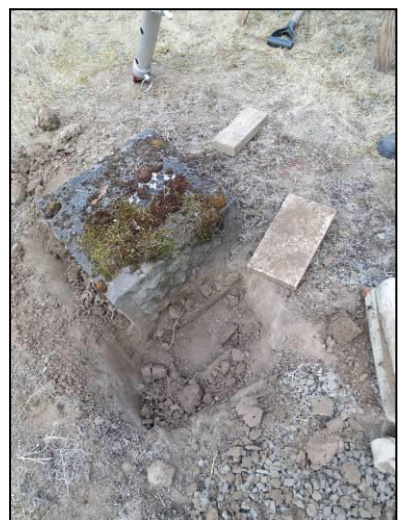
This buried footstone was uncovered while releveling Marker 20.01.

Each dislocated stone should be marked as to where it came from. Using the current system of RR.MM, where “RR” is the row and “MM” is the burial incrementing from the north, note the dislocated stone’s location relative to its neighboring, permanent markers. Place a spike with a piece of labeled flagging tape flush with the ground at its found location. Tag the stone fragment by writing in pencil the RR.MM number on an edge of the dislocated stone. Also, place a [marker inventory sheet](#) with the stone and place a copy on file. All of this labeling will aid in returning the stone to its found location and help in relocating stones accurately.

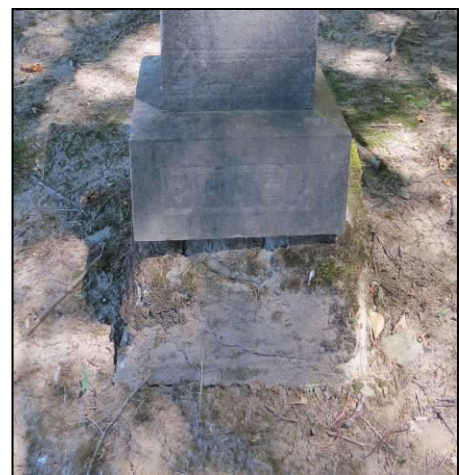
The base under the plinth of #15.25 is made of sandstone and has eroded to a dangerous degree and likely will need replacement.

Replacement: Replace existing bases or plinths only if the deterioration compromises the headstone or upper portion of the monument. According to the survey inventory, 50% of the bases are made of sandstone. Many are deteriorated and are figured into the repair statistics. If base replacement is necessary, match the size of original base or plinth. Ideally, the replacement should be reconstructed using the same material and pattern as the original. If this

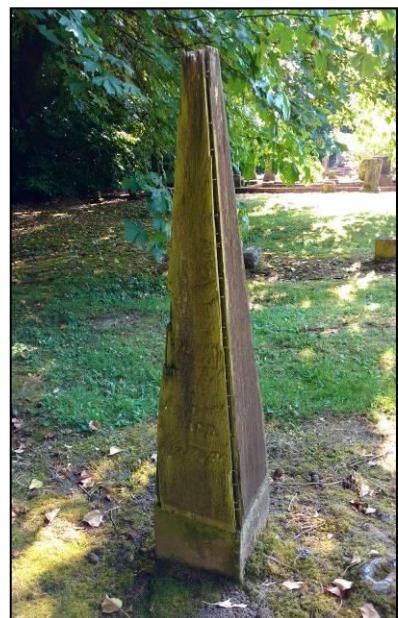
Marker #08.26 for Lena Crosby is the only wooden marker in the cemetery.

There is one wooden marker in the cemetery and it needs to be stabilized. Prior to work, photograph and measure the marker, and record the faint epitaphs. Remove the wooden marker to a controlled environment for repair, do not repair on-site. Employ a competent woodworker to do the repair. The open joint needs to be refastened after a thorough assessment. Pre-drill holes for new finish nails, do not use screws. Do the work in the spring or fall after the wood has rehydrated to prevent splitting. Do not use a glue or epoxy on the joint, make sure the repair is reversible. Consider applying a mixture of boiled linseed oil, paraffin, and mineral spirits to provide a breathable protective layer on the wood marker. Do not use any other sealer on the marker.

If the marker is too deteriorated for repair, the Committee should consider replacing the marker with a replica, matching the original's color, size, and wood type. This work can be performed by a competent woodworker and does not need to be a skilled artisan. Inscribe information on the inside of the new monument stating that it is a replacement marker and the date in which it was recreated. Store the original wooden marker in the back of the off-site storage area with label describing its original location.

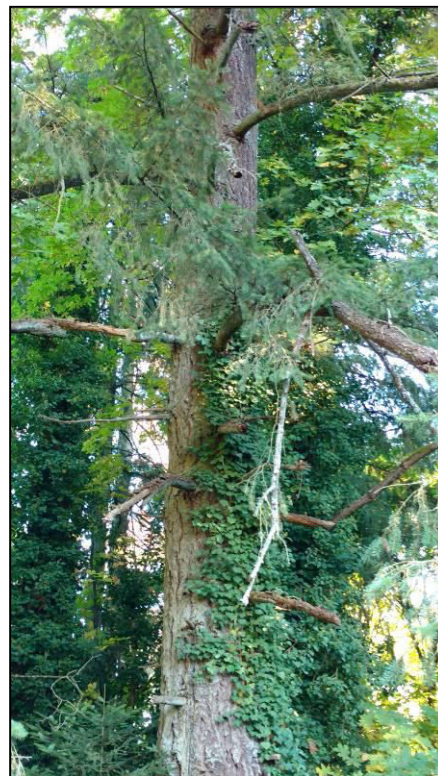
Douglas fir with numerous widow makers in need of trimming.

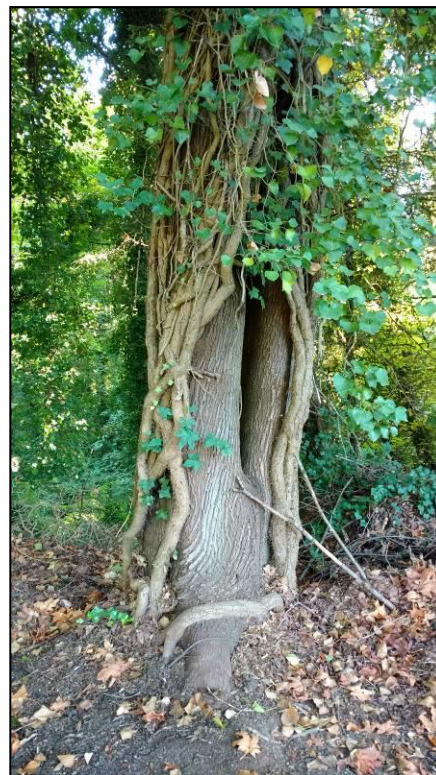
Ivy strangling a maple. Ivy should be cut at the base and left for a year to die.

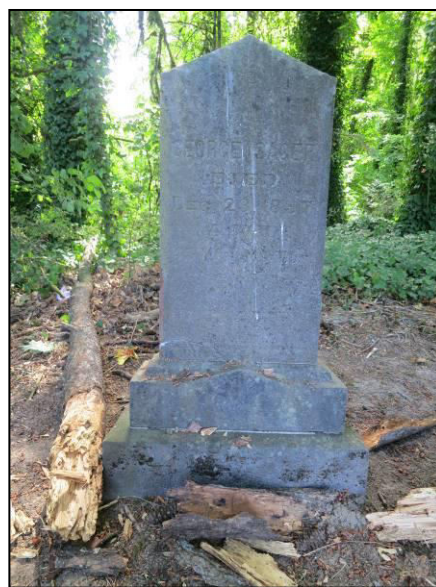
A widow maker crashed down over Winter 2018 and damaged Marker #01.23.

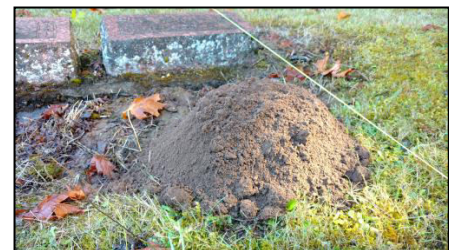
Animals

Signs of fresh burrowing in the cemetery.

Animals have dug burrows in the cemetery, causing damage to burial plots, markers, and curbing. The gophers, moles and other burrowing animals will need to be eliminated from the cemetery. There are a variety of humane methods of removing burrowing animals that the Public Works Department should consider employing. The Oregon Department of Fish and Wildlife ([ODFW](#)) can often help treat this issue. The situation is not dire but should be addressed soon.

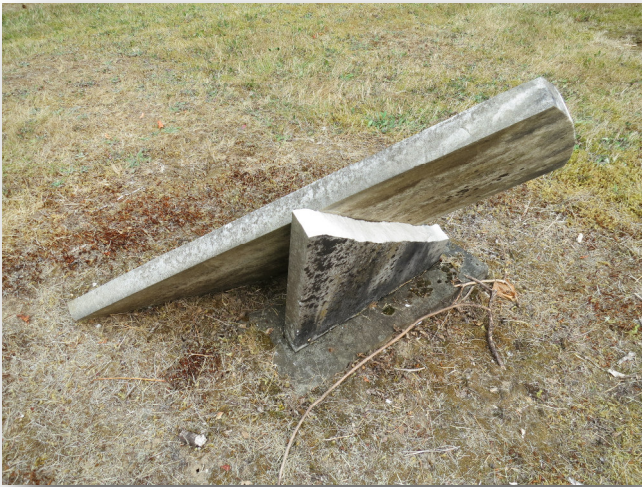
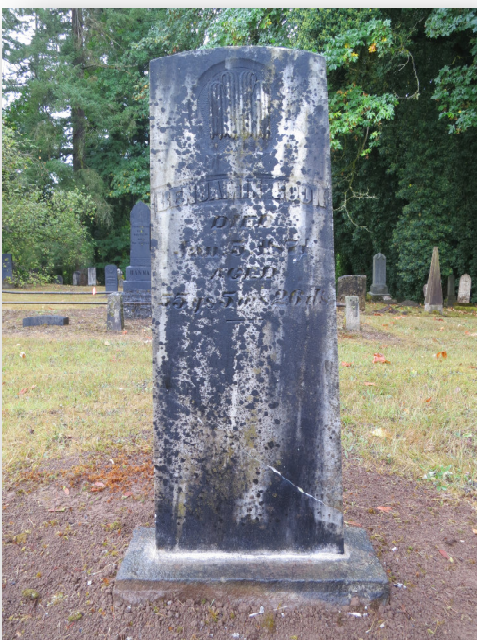
Marker 09.23. HANNA.

TO DO: Raise, level, reset, and repair.

COMPLETED: Raised base 4" above grade, leveled on bed of 3/4" minus gravel, reset stone in lime mortar within base slot, and repaired break with Akepox epoxy.

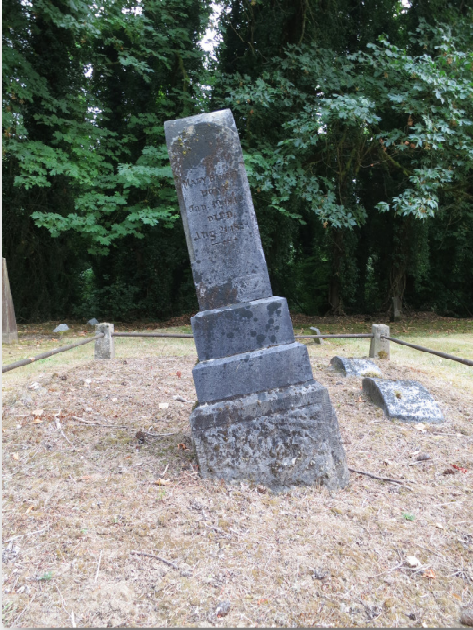
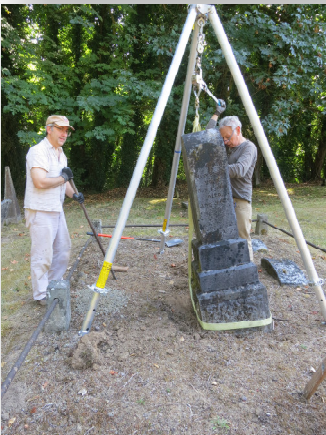
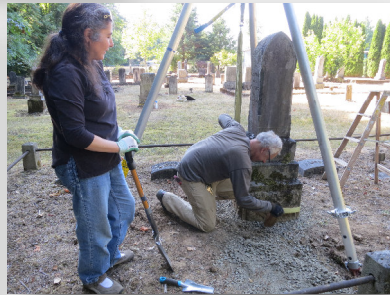
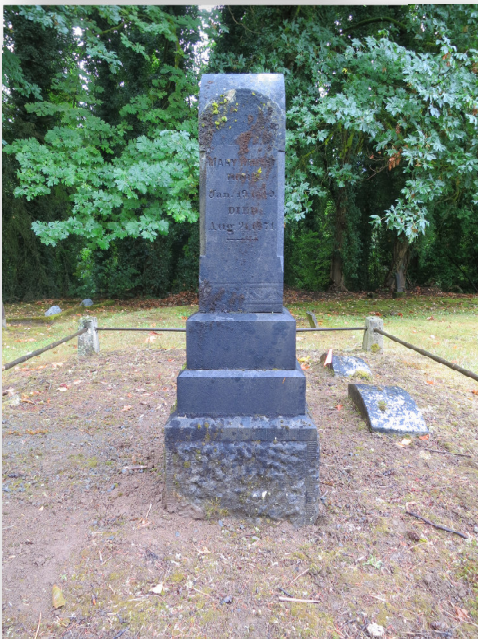
Marker 08.25. J JACOBS.

TO DO: Relevel, currently at 12 degrees.

COMPLETED: Lifted, leveled on bed of 3/4" minus gravel, and packed in.

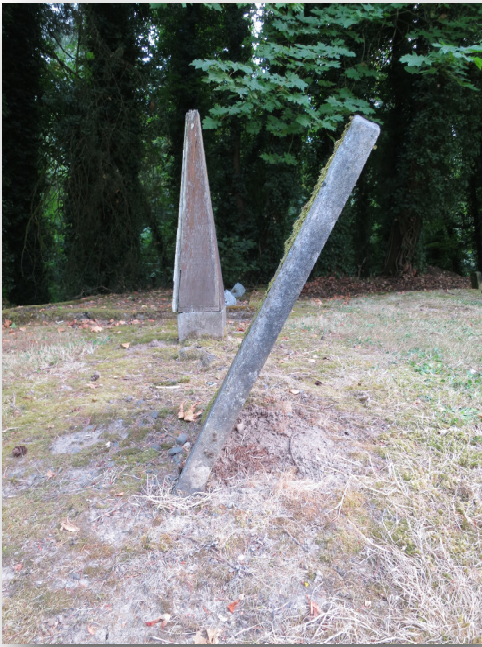
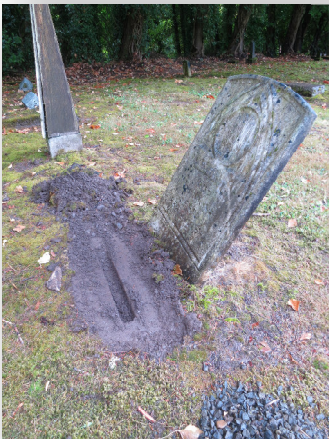
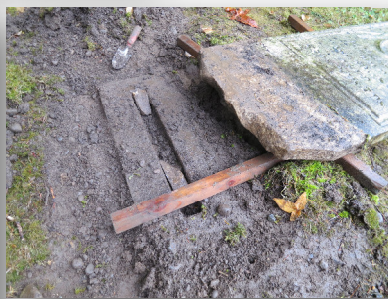
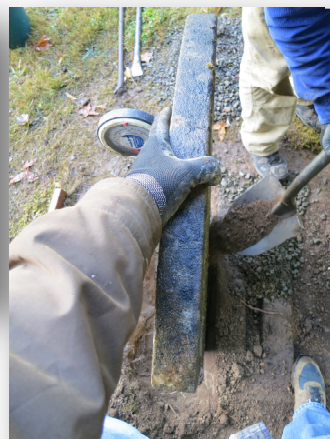
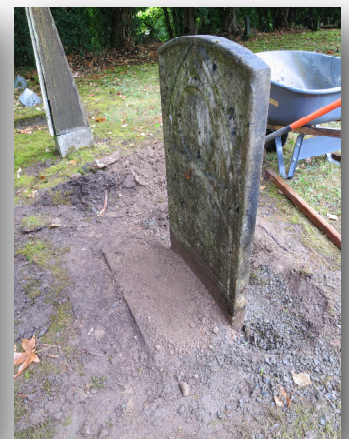
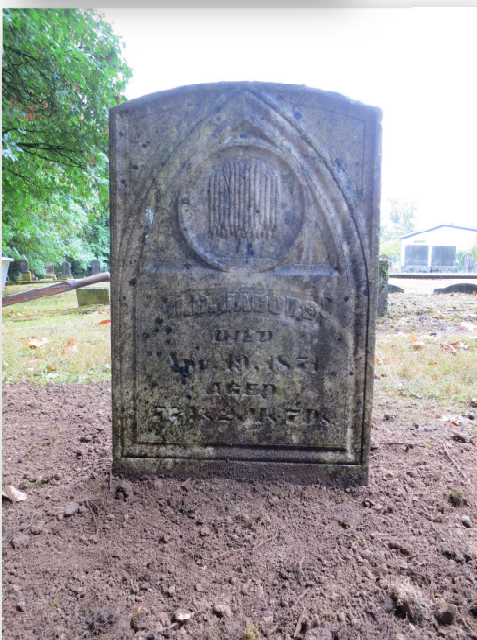
Marker 08.19. Ralph JACOBS.

TO DO: Relevel, currently at 25 degrees.

COMPLETED: Uncovered original slotted base in front of stone, determined stone bottom edge too uneven to reinsert in slot, stood stone upright at front of base on bed of 3/4" minus gravel, and packed in.

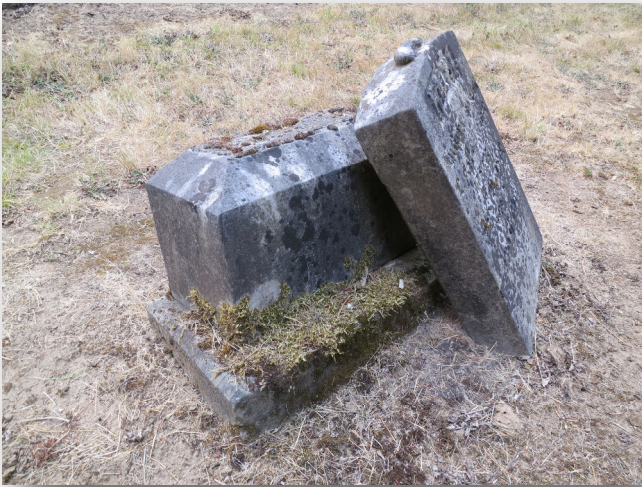
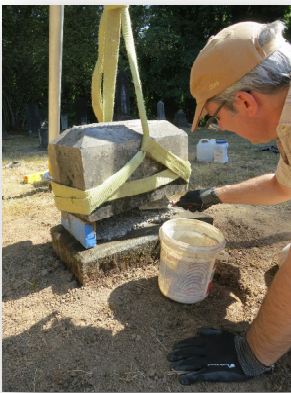
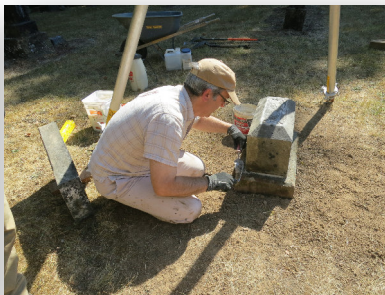
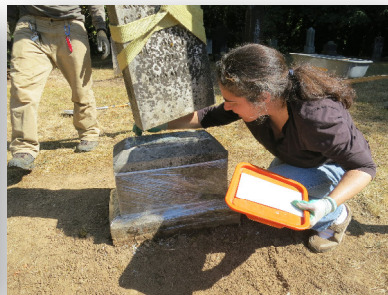
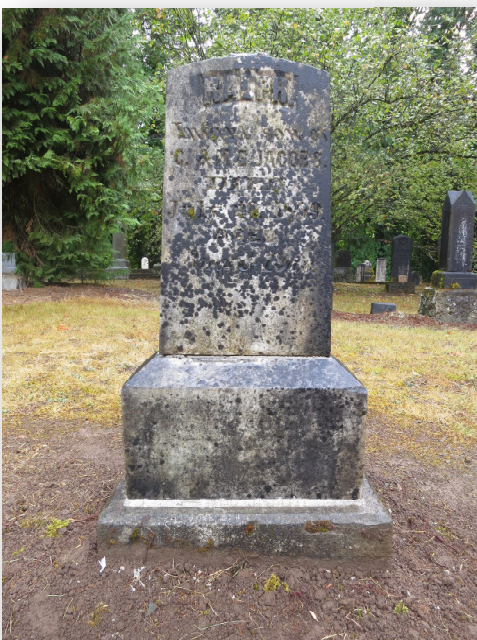
Marker 08.09. Frank HILL.

TO DO: Level and reset.

COMPLETED: Levelled base on bed of 3/4" minus gravel, reset plinth in lime mortar, and reset stone in Akepox epoxy.

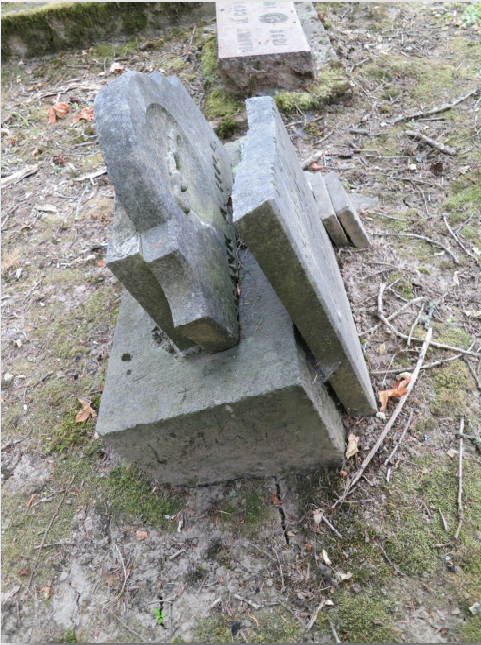
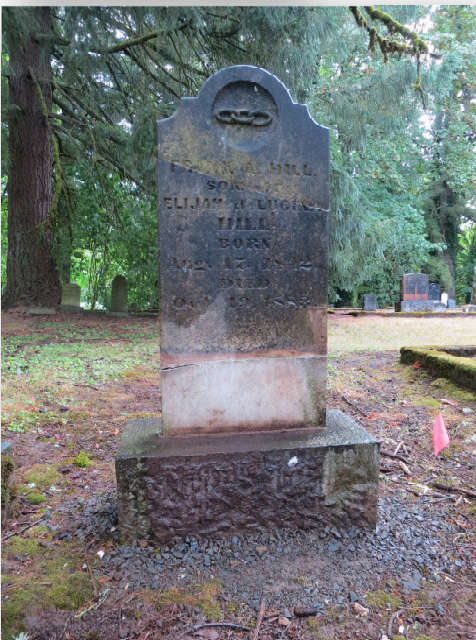
TO DO: Repair three breaks, two of which are old glue breaks.

COMPLETED: Leveled base on bed of 3/4" minus gravel and repaired two breaks with Akepox epoxy.

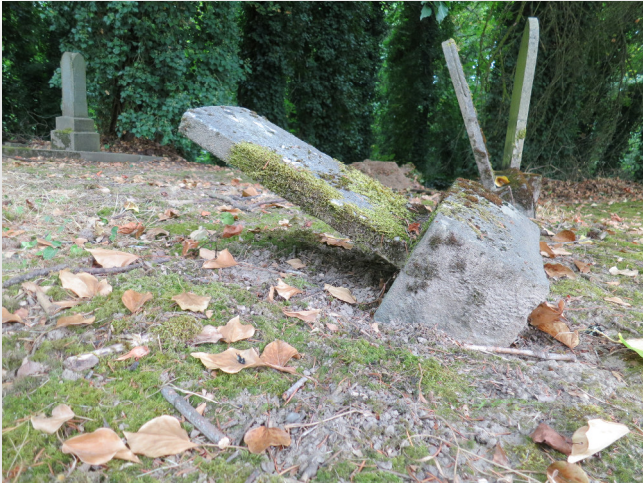
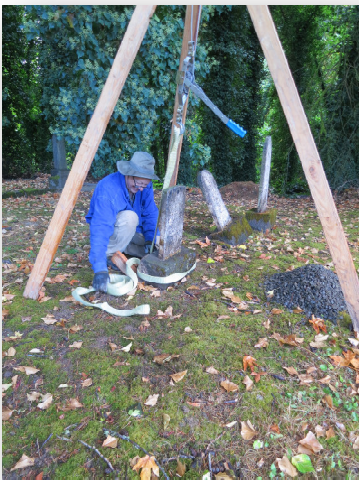
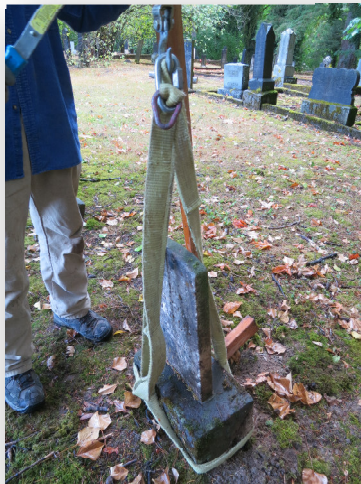
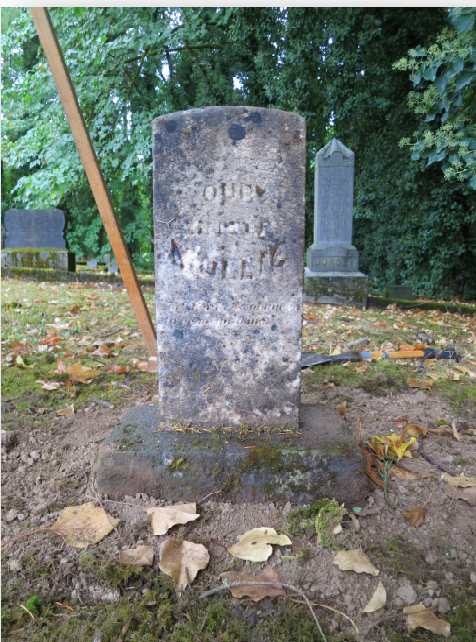
Marker 07.25. Mary SMITH.

TO DO: Relevel, currently at 67 degrees.

COMPLETED: Leveled on bed of 3/4" minus gravel and packed in.

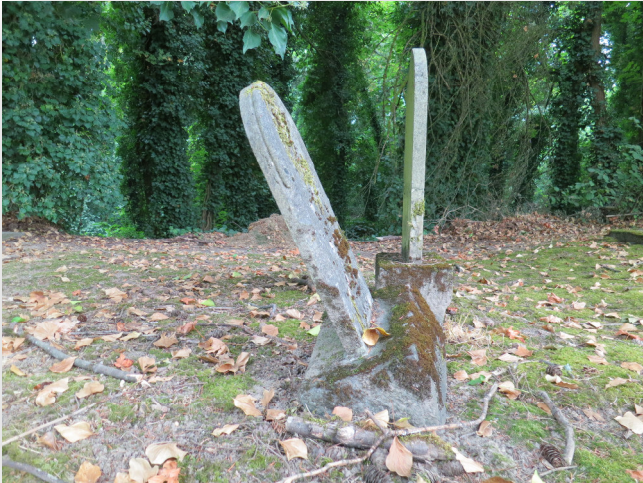
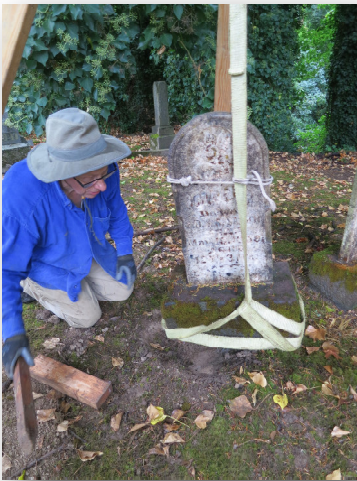
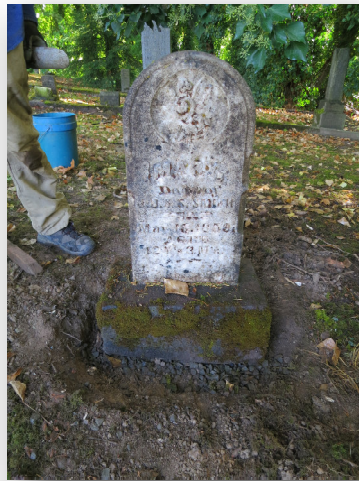
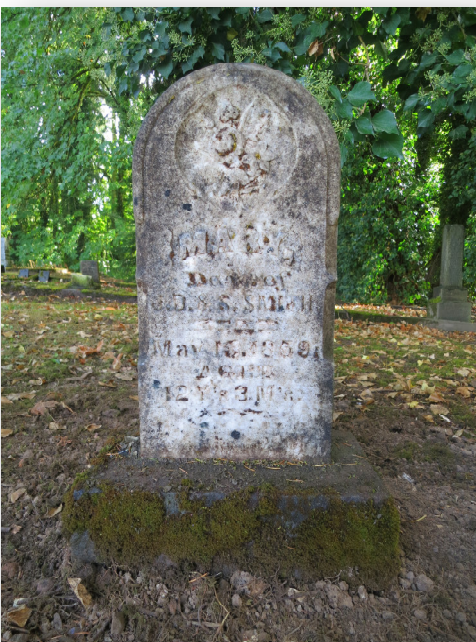
Marker 06.28. Martin GIBBS.

TO DO: Relevel, currently at 25 degrees.

COMPLETED: Leveled on bed of 3/4" minus gravel and packed in.

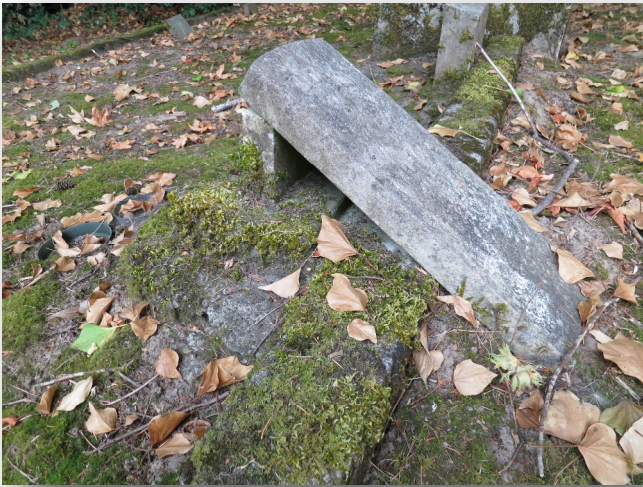
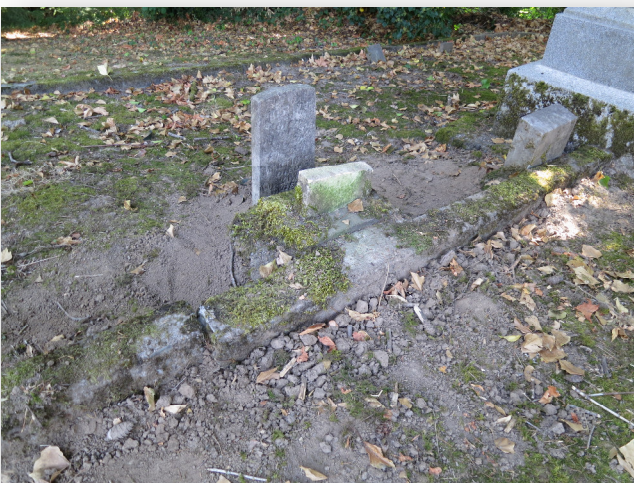
TO DO: Relevel and repair.
One old glue break.

COMPLETED: Found stone
base attached to curb and could
not break free to level base.
Placed headstone upright behind
base to protect from lawn mow-
ers and packed in.

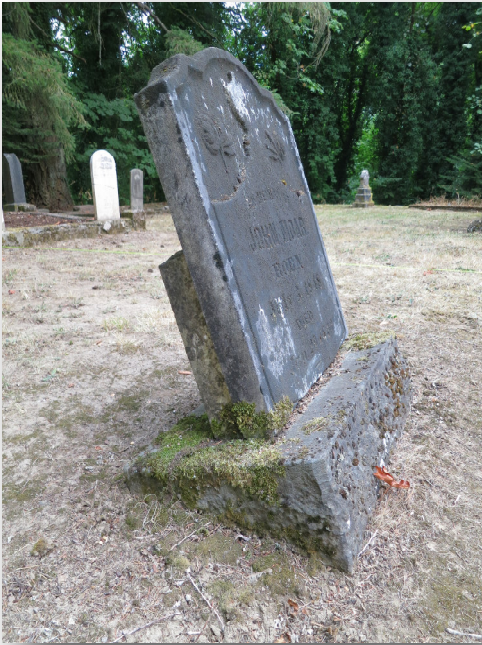
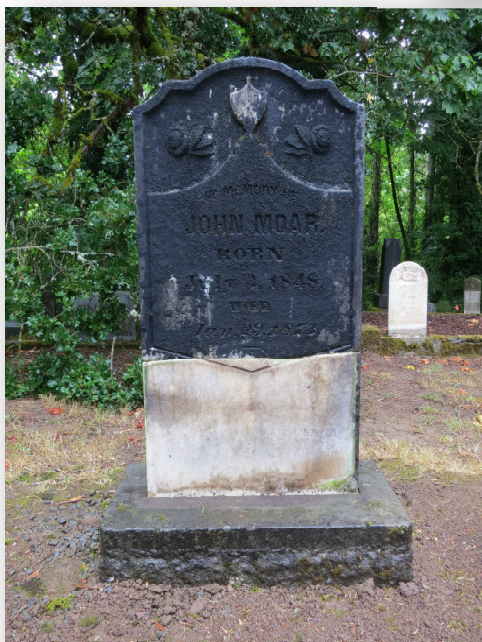
TO DO: Level and repair one old break.

COMPLETED: Leveled on bed of 3/4" minus gravel, packed in, and repaired break with Akepox epoxy.

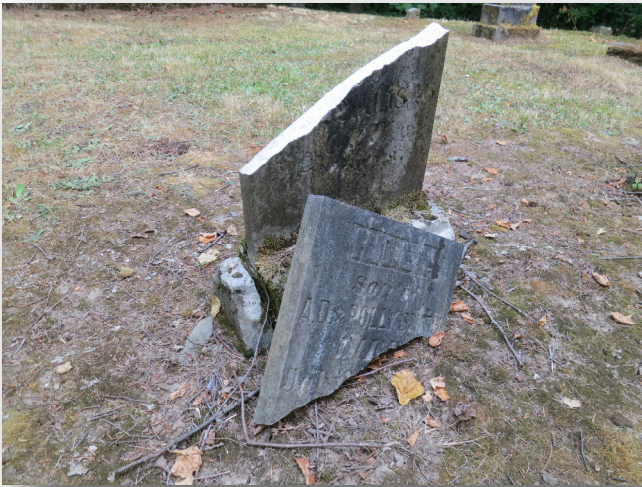
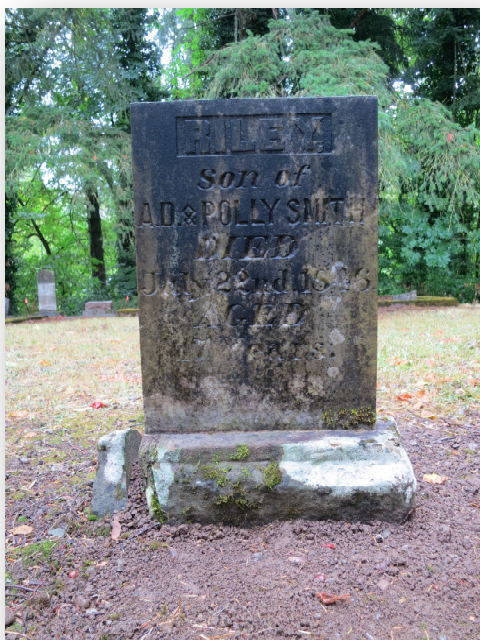
TO DO: Relevel and repair one fresh break.

COMPLETED: Found sandstone base bedded vertically with a large spall off the north end of the base. Left spall firmly in place and leveled remaining base on bed of 3/4" minus gravel. Repaired fresh break with Akepox epoxy.

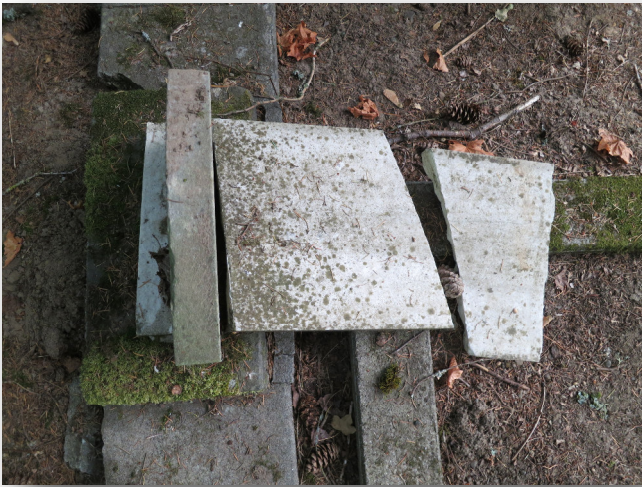
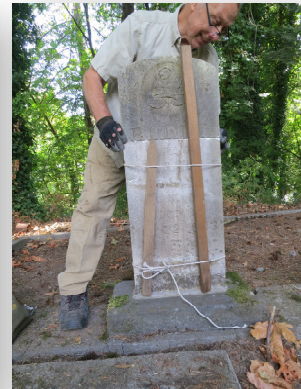
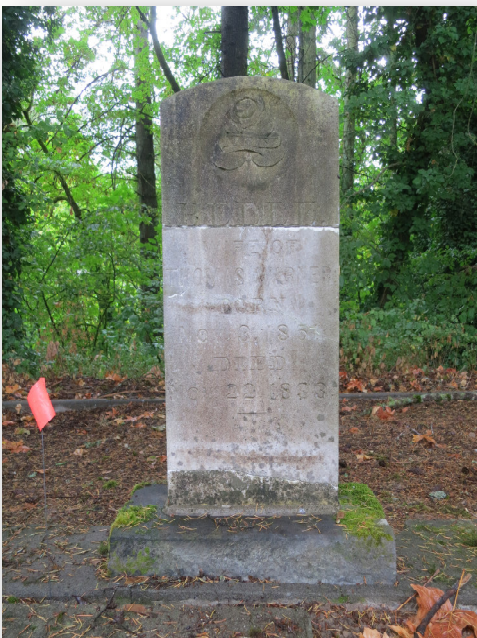
TO DO: Repair three breaks.

COMPLETED: Repaired three breaks with Akepox epoxy.

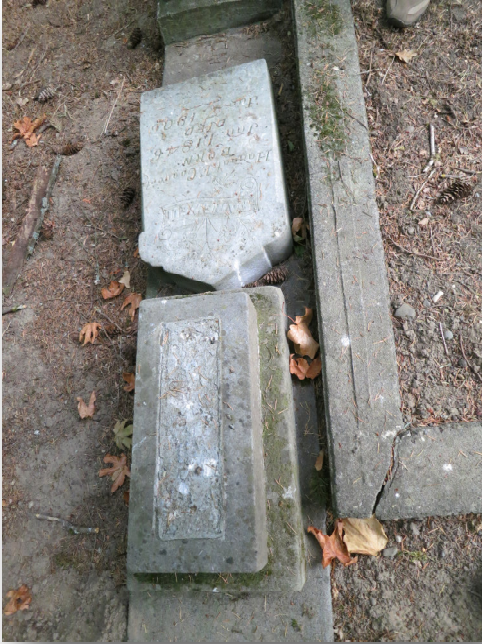
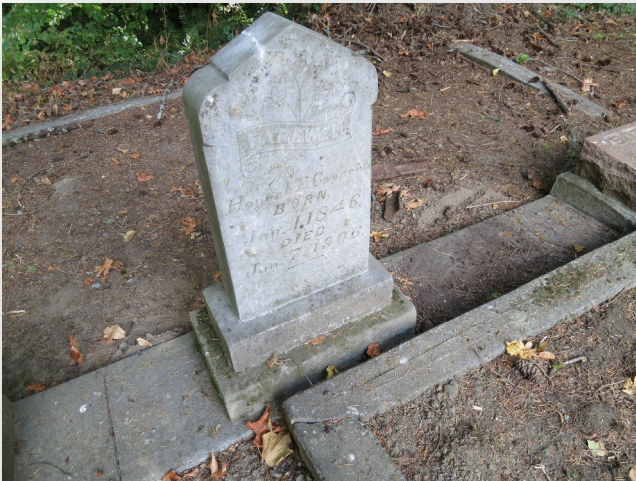
Marker 01.21. Hannah COOVERT.

TO DO: Reset

COMPLETED: Reset stone in Akepox epoxy.

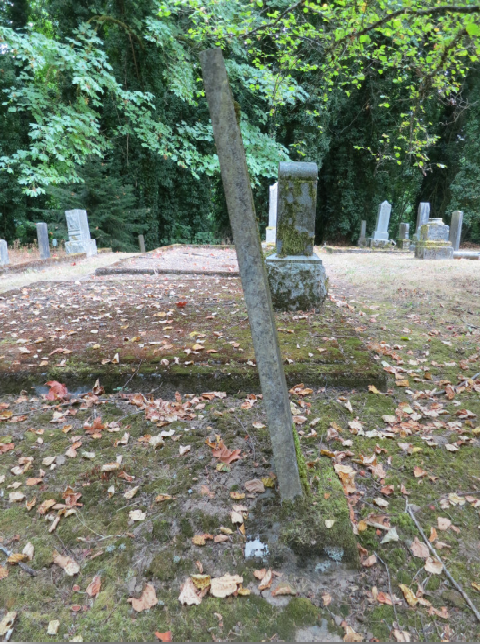
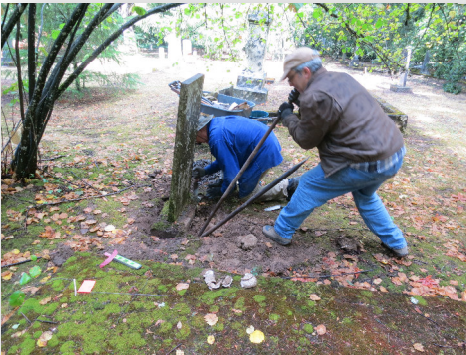
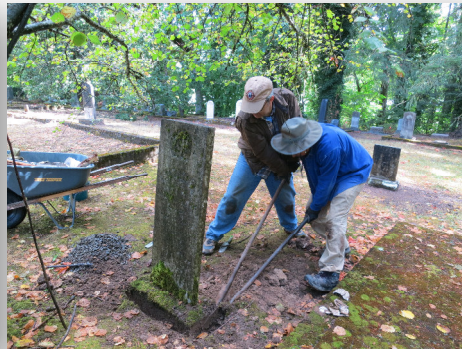
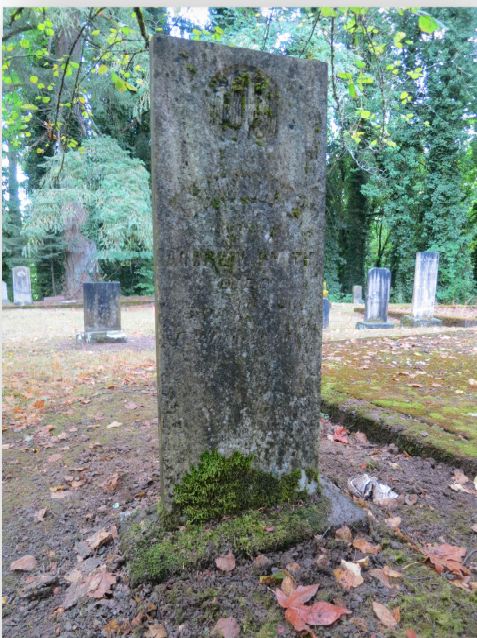
Marker 05.17. Sarah SMITH.

TO DO: Relevel, currently at 17 degrees.

COMPLETED: Leveled on bed of 3/4" minus gravel and packed in.
