Brookside Cemetery 2018-2027 Preservation Plan

Written by: David Pinyerd and Bernadette Niederer
Historic Preservation Northwest
1116 11th Ave SW
Albany OR 97321
541-791-9199
www.hp-nw.com

Written for: City of Dayton
Dayton School District
Brookside Cemetery Association

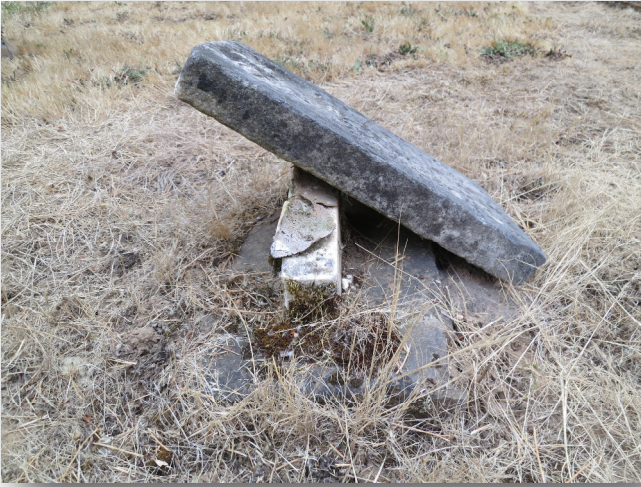
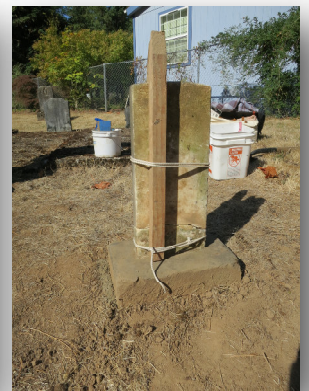
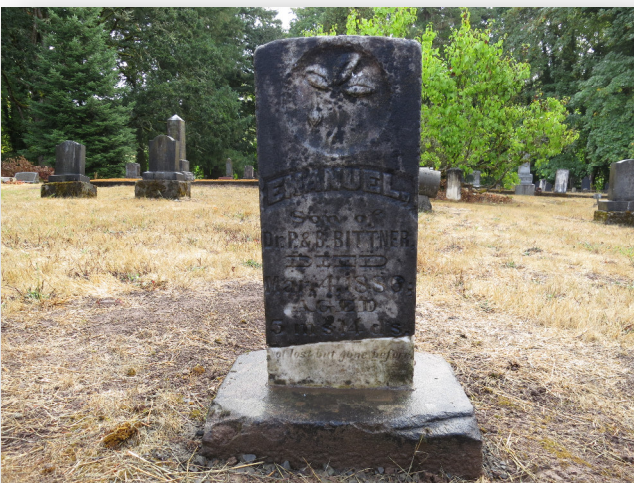
TO DO: Level and repair one old glue break.

COMPLETED: Raised base 4" above grade, leveled on bed of 3/4" minus gravel, and repaired break with Akepox epoxy.

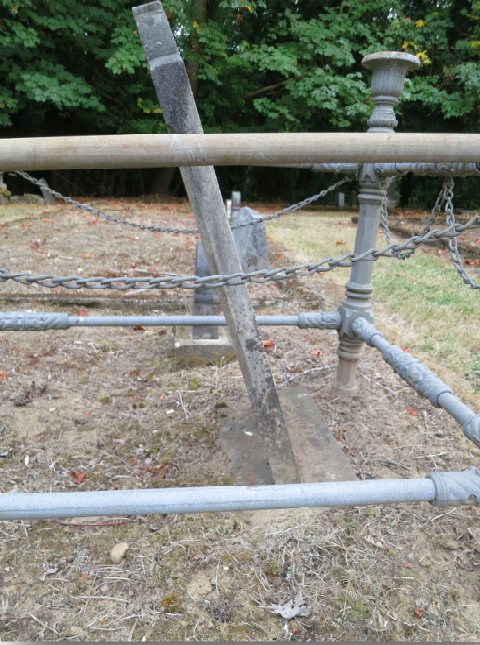
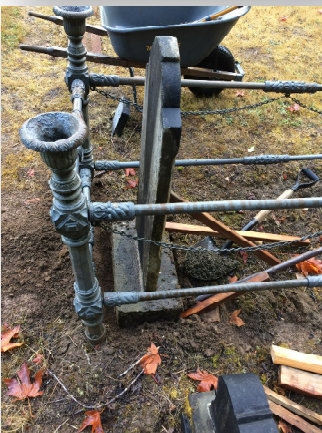
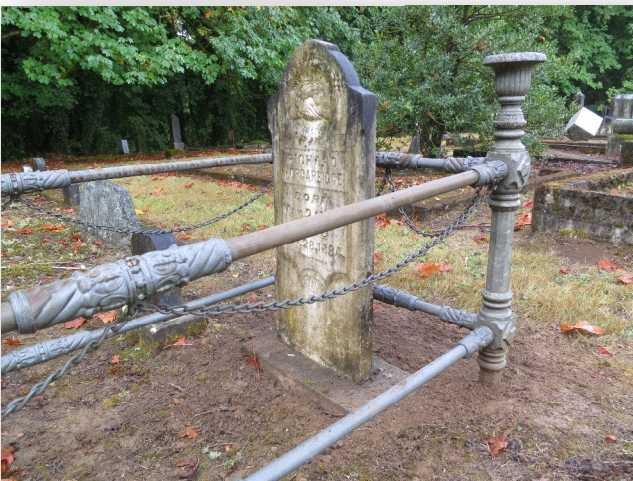
Marker 14.13. Richard MORGAREDEGE.

TO DO: Relevel, currently at 20 degrees.

COMPLETED: Levelled on bed of 3/4" minus gravel and packed in.

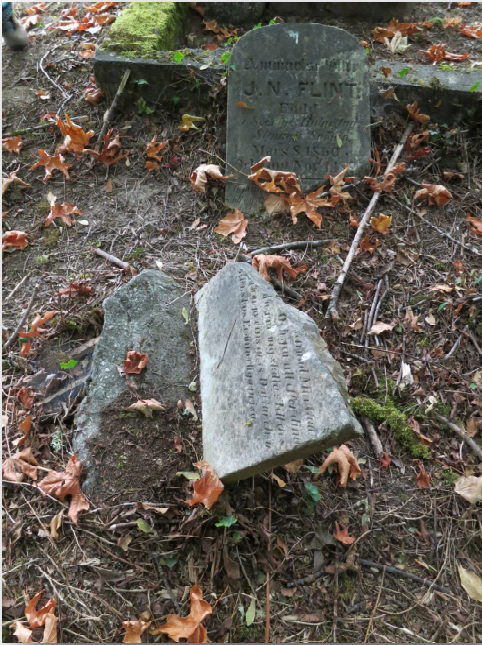
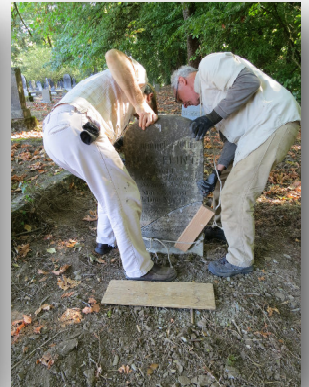
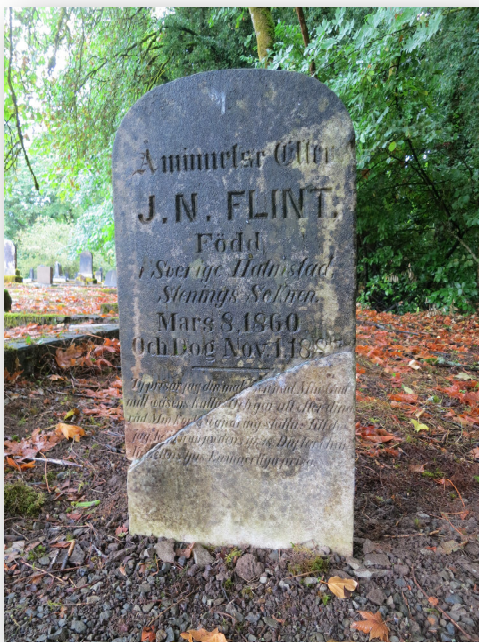
TO DO: Relevel and repair one old glue break.

COMPLETED: Found marker bottom was embedded in concrete, so left concrete attached and leveled on bed of 3/4" minus gravel. Repaired break with Akepox epoxy.

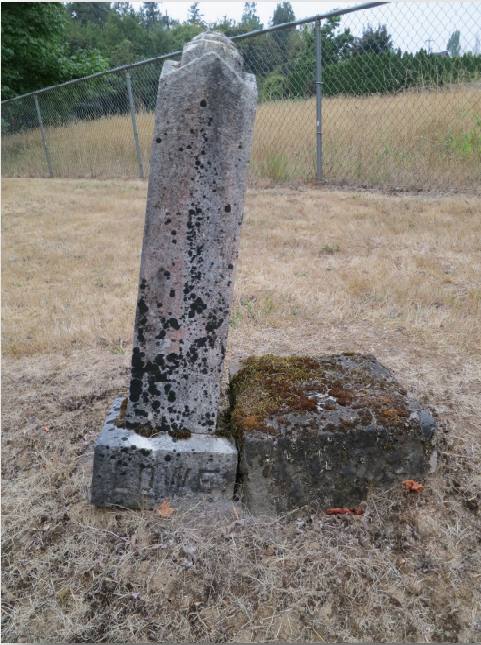
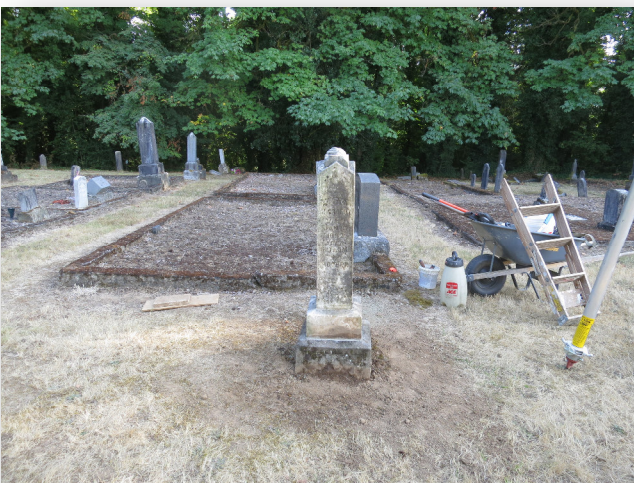
TO DO: Level base and reset stone.

COMPLETED: Found marble footstone while leveling base and placed footstone next to base. Leveled on bed of 3/4" minus gravel, packed in, and reset stone in lime mortar.

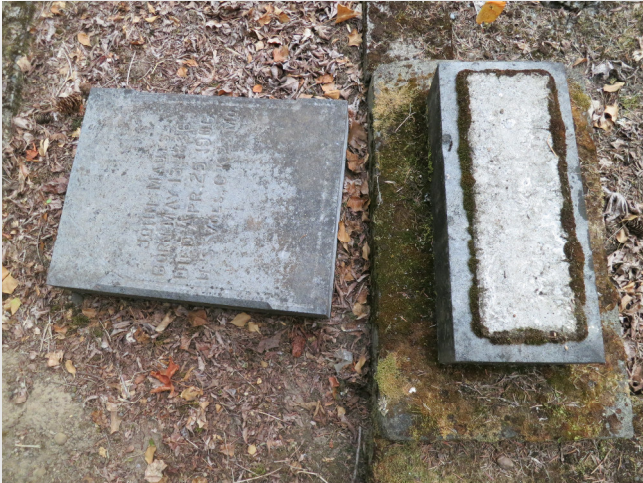
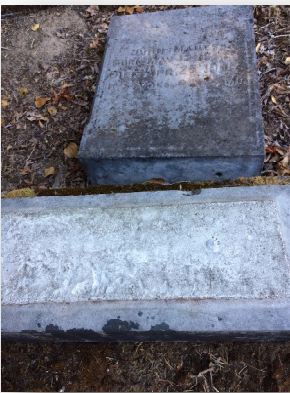
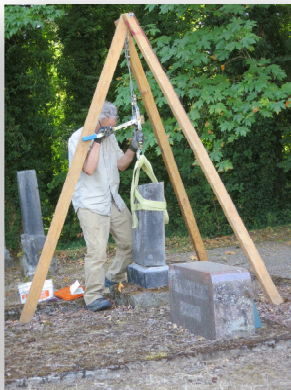
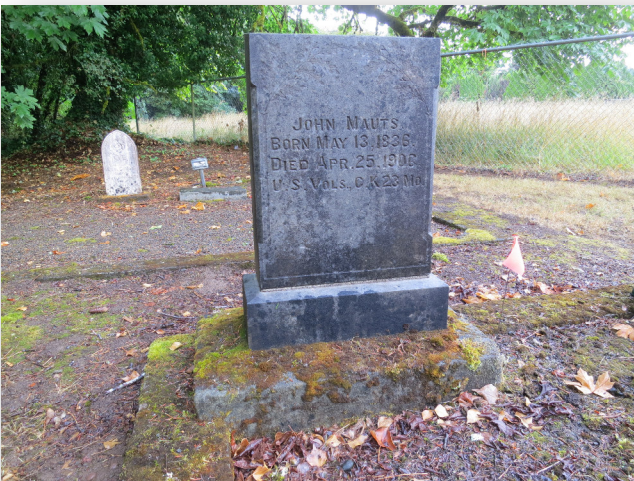
Marker 23.02. John MAUTS.

TO DO: Reset

COMPLETED: Reset stone in Akepox epoxy.

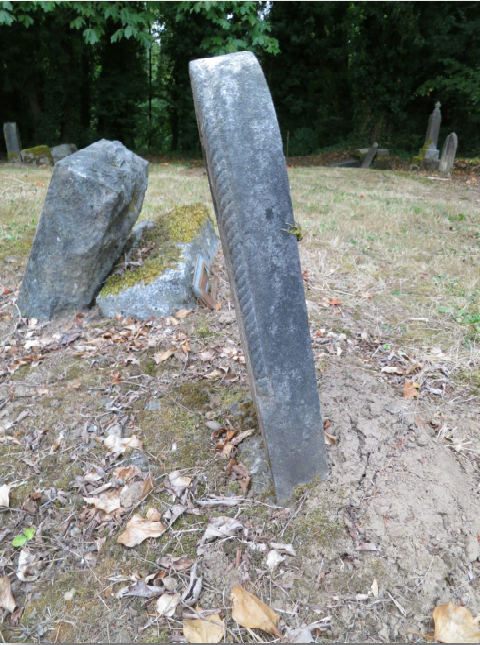
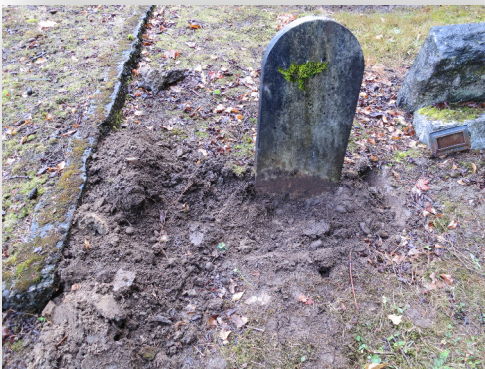
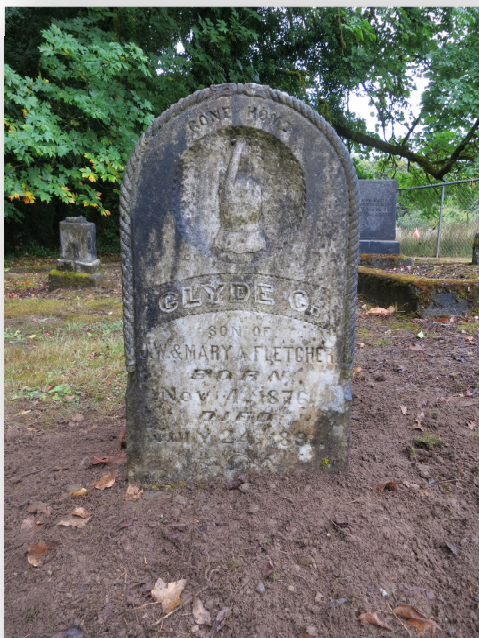
Marker 22.02. Clyde FLETCHER.

TO DO: Relevel, currently at 14 degrees.

COMPLETED: Leveled on bed of 3/4" minus gravel and packed in.
